**BOARD OF PILOT COMMISSIONERS FOR THE  
BAYS OF  
SAN FRANCISCO, SAN PABLO, AND SUISUN**

**INCIDENT REVIEW COMMITTEE  
INVESTIGATION REPORT**

**REPORT OF THE DOCKING OF THE P/V STAR PRINCESS AT  
SAN FRANCISCO (PIER 27), ON OCTOBER 2, 2019  
PILOT: CAPTAIN ORRIN FAVRO**

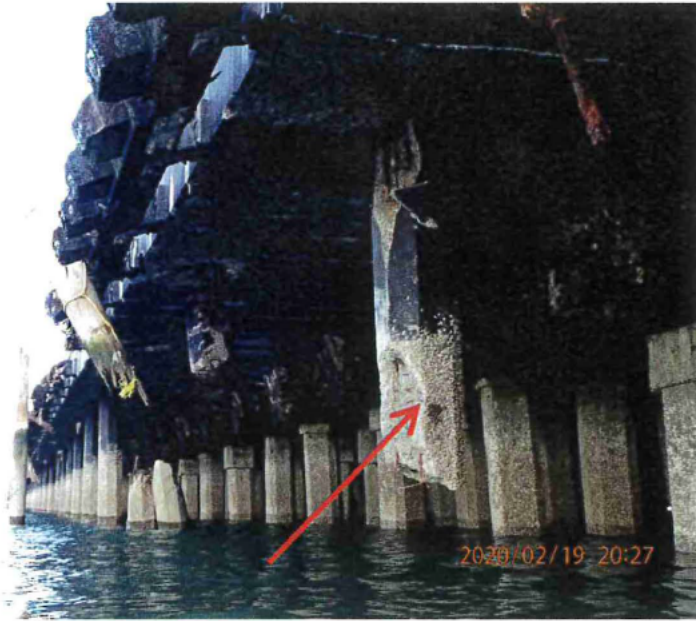
**Photo 1**

- Concrete Apron Piles 14a, 15a, and 16a were severely damaged and are currently without any load carrying capacity. Pile 16a was completely separated from the apron soffit and was not visible. Piles 14a and 15a each failed in shear at the apron and were dangling from the soffit by prestressing strands and swaying with the tide, indicating separation from the underwater portions of the piles.
- The underwater portion of piles 14a, 15a, and 16a are all deflected towards the southwest under the apron.
- The two piles in Row A adjacent to the damaged piles had no signs of damage from the allision and only showed light deterioration leading to a rating of Minor.
- A large portion of the apron soffit cover at Piles 14a and 15a had spalled. Minor corner spalling of the soffit was also observed at these locations.

Broken Pile 14a

**Severe Condition - 14a** - Large section of concrete pulled out of deck above pile with exposed reinforcement; ~6' segment of prestressed pile hanging from deck by prestressing strands; Bottom segment of piles deflected to the SW, resting on mudline; Top of deflected pile segment located ~4' below MLW positioned ~6" East of pile 9C

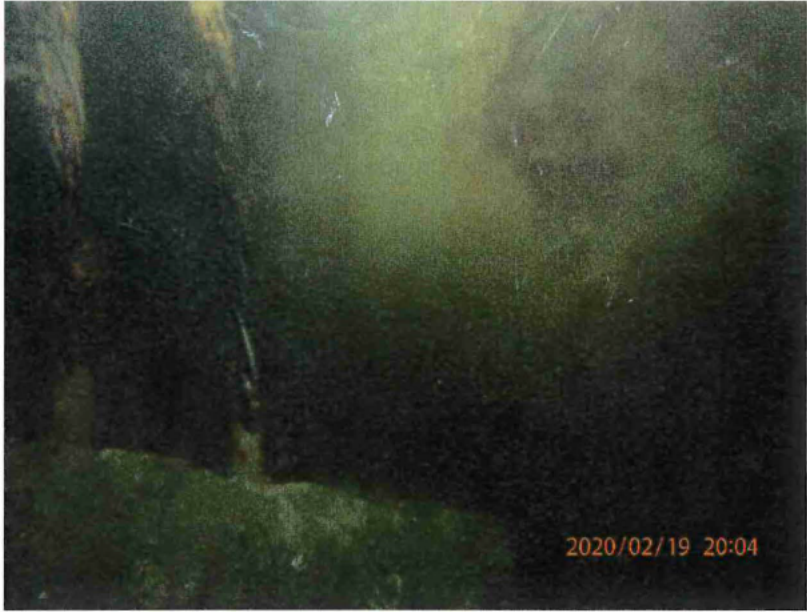
**Photo 3**

Broken Pile 14a  
underwater

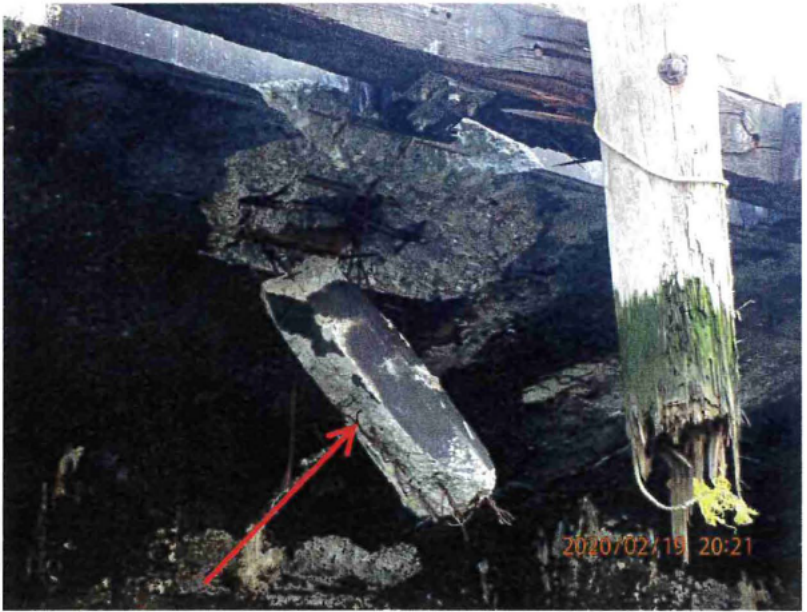
**Photo 4**

Broken Pile 15a

**Severe Condition - 15a** - Large section of concrete pulled out of deck above pile with exposed reinforcement; ~3' segment of prestressed pile hanging from deck by prestressing strands; Bottom segment of pile sheared below ML, sheared segment embedded into mudline and positioned approximately 6 inches from the SW corner of pile 12B at the mudline.

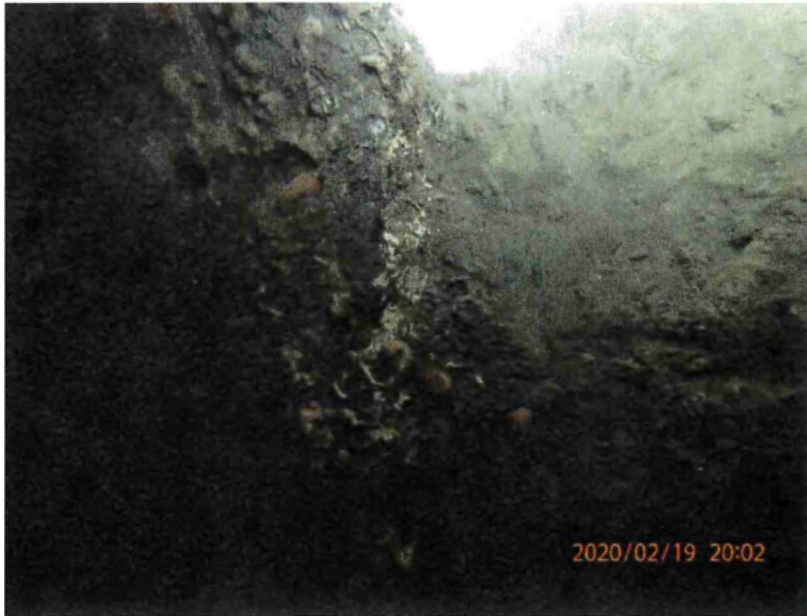
**Photo 5**

Broken Pile 15a  
underwater

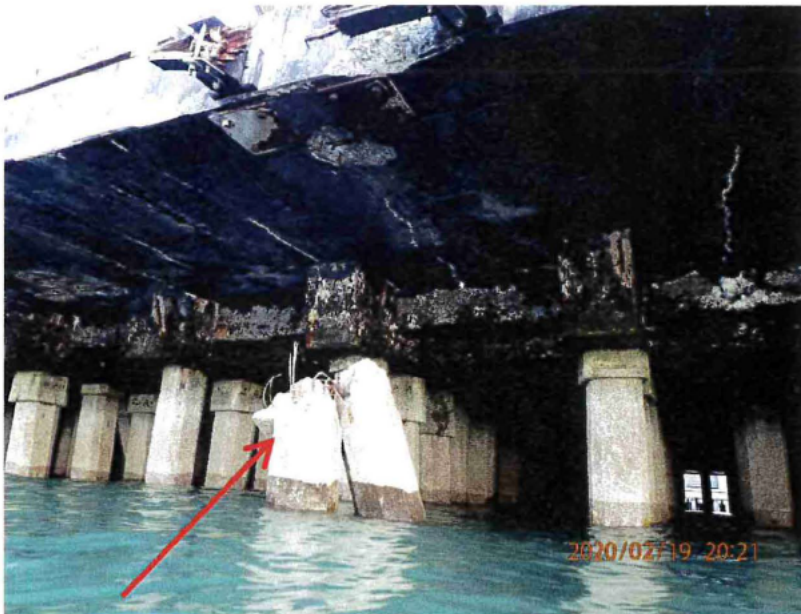
**Photo 6**

Broken Pile 16a

**Severe Condition - 16a** - Large section of concrete pulled out of deck above pile with exposed reinforcement; Pile detached from deck with a shear failure and hanging from strands ~3' above MLW; Bottom segment of pile still embedded into the mudline; condition of bottom segment unknown due to unsafe conditions, i.e. hanging concrete pile; potential for fractures at or near mudline to be investigated following removal of hanging debris

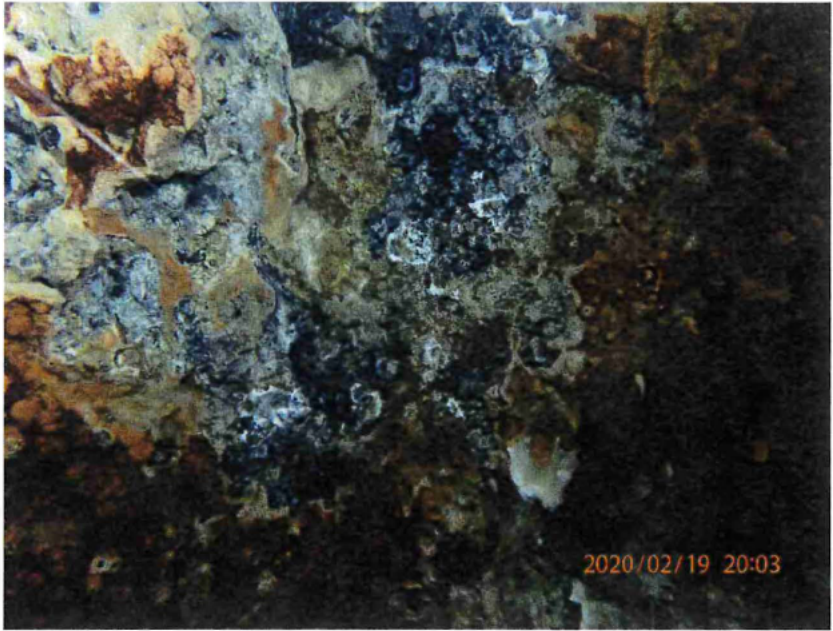
**Photo 7**

Erosion of pile chamfer at  
Pile 18B – Pile rated Major

**Advanced Condition - 18B** - Light efflorescence in deck and cap above pile (Typ.); No apparent impact-induced defects; No observed change in marine growth to ML; Heavy erosion and up to 3/8" cracking at chamfers in tidal zone. 24" height, on offshore faces - UW Photo Location - Erosion of chamfers

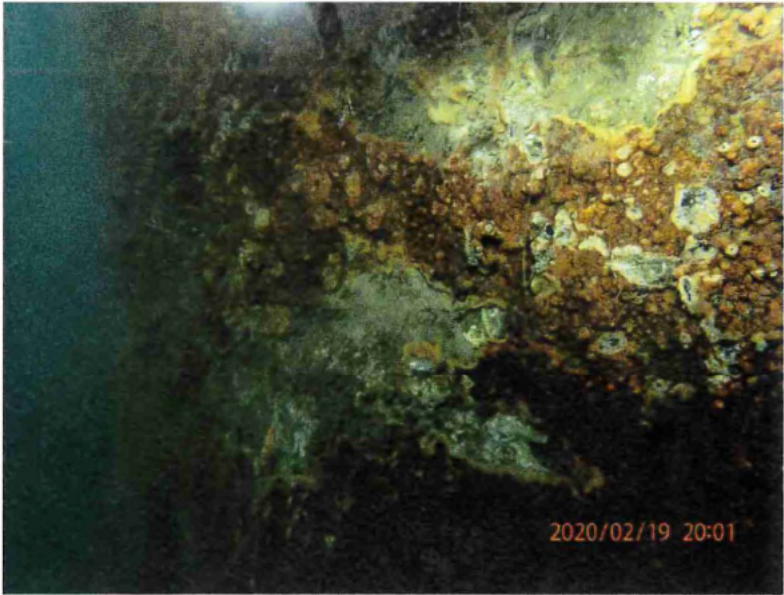
**Photo 8**

Moderate condition of  
Pile 21B

**Moderate Condition - 21B** - Top of pile, 6" tall encasement repair with 2-3" annulus; Failed repair on S face; Moderate chamfer erosion 8' below MLW, not impact related, marine growth present over defect;

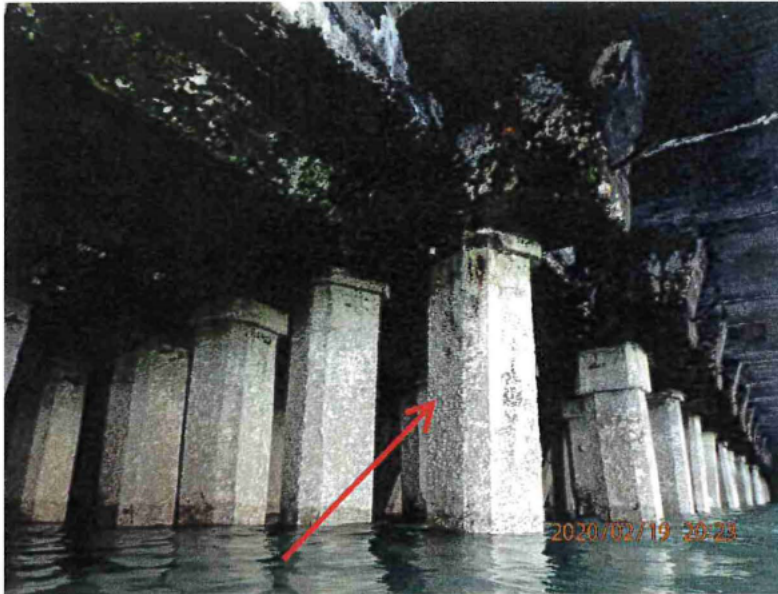
**Photo 9**

Pile 21B above water

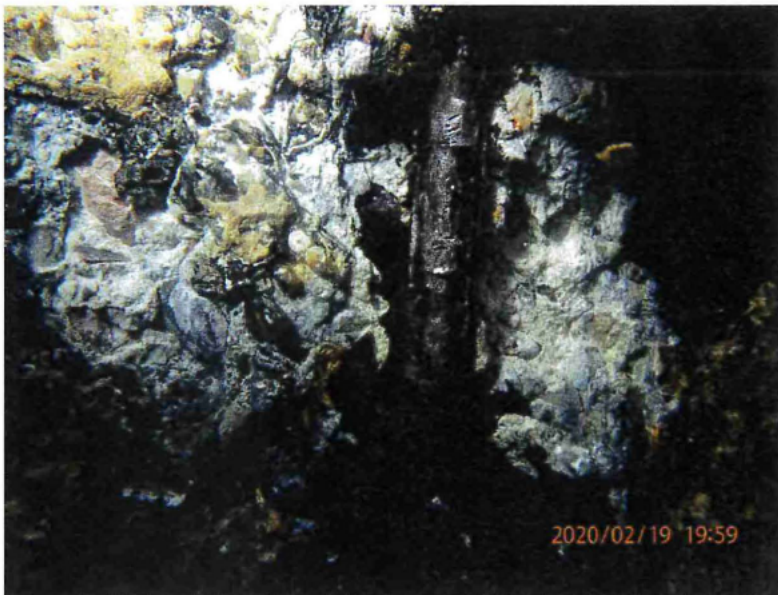
**Photo 10**

Severe condition of  
Pile 22B with exposed  
reinforcing

**Severe Condition - 22B** - Top of pile 12" tall encasement 2-3" annulus; NW face 2' below WL, 2' height, heavy spall/erosion with exposed reinforcement, not likely impact related; Light chamfer erosion 1' below MLW on NW face, varying levels of light to moderate erosion down to 12' below MLW, not impact related, marine growth present over defects

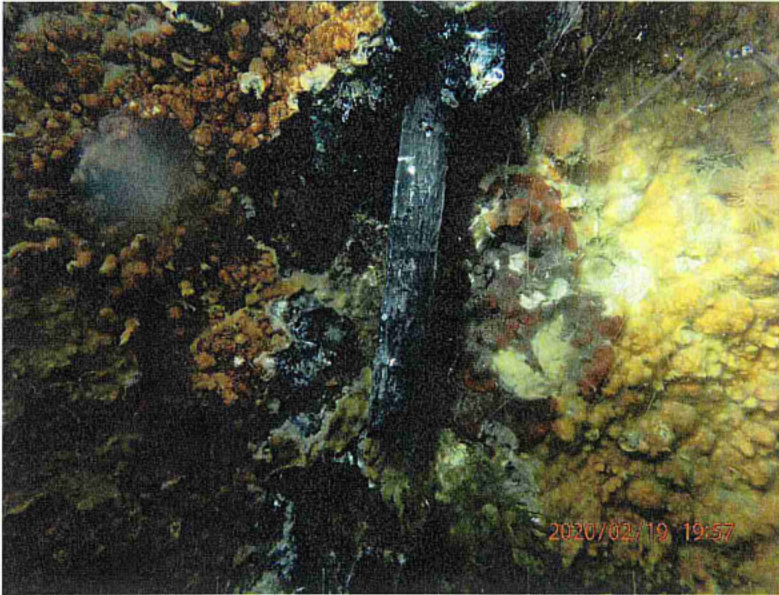
**Photo 11**

Severe condition of  
Pile 23B with exposed  
reinforcing

**Severe Condition - 23B** - Top of pile 6" tall encasement 2-3" annulus; SW face 2' below WL, 2' height, heavy spall/erosion with exposed reinforcement, not impact related; Light chamfer erosion 1' below MLW, varying levels of light to moderate erosion down to 12' below MLW, not impact related, marine growth present over defects
