# National Transportation Safety Board

## Marine Accident Brief

### Contact of Liquid Petroleum Gas Carrier *Levant* with Mooring Dolphin

<b>Accident type</b>	Contact	<b>No.</b> DCA20FM006
<b>Vessel name</b>	<i>Levant</i>	
<b>Location</b>	Petrogas Ferndale Wharf, about 5 miles west of Ferndale, Washington <sup>1</sup> 48°50.36' N, 122°43.26' W	
<b>Date</b>	December 15, 2019	
<b>Time</b>	0406 Pacific standard time (coordinated universal time – 8 hours)	
<b>Injuries</b>	None	
<b>Property damage</b>	\$8.25 million est.	<b>BOPC Received</b> <b>02-04-2021</b>
<b>Environmental damage</b>	None	
<b>Weather</b>	Visibility 7 miles, overcast, winds west-northwest at 15 knots, waves 2 feet, air temperature 45°F, water temperature 46°F, sunrise 0751	
<b>Waterway information</b>	Located in the Strait of Georgia, the Petrogas Ferndale Wharf's depth alongside at mean lower low water is about 36 feet, height of tide 2.9 feet, and mean range of tide 5.9 feet.

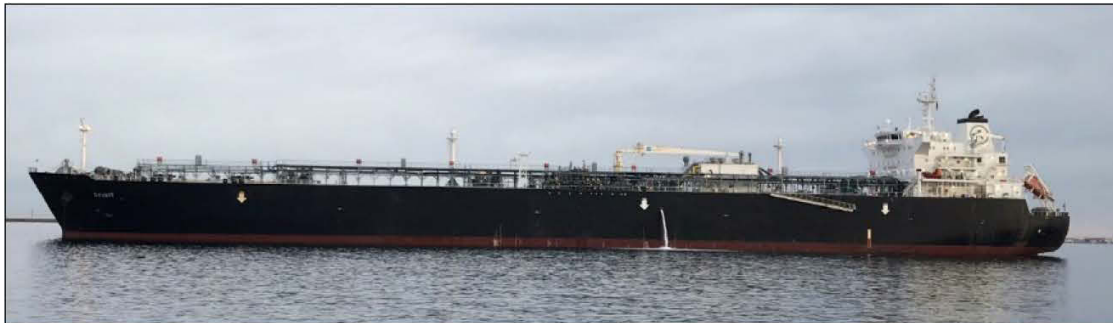
Postaccident photo of the *Levant* at anchor.

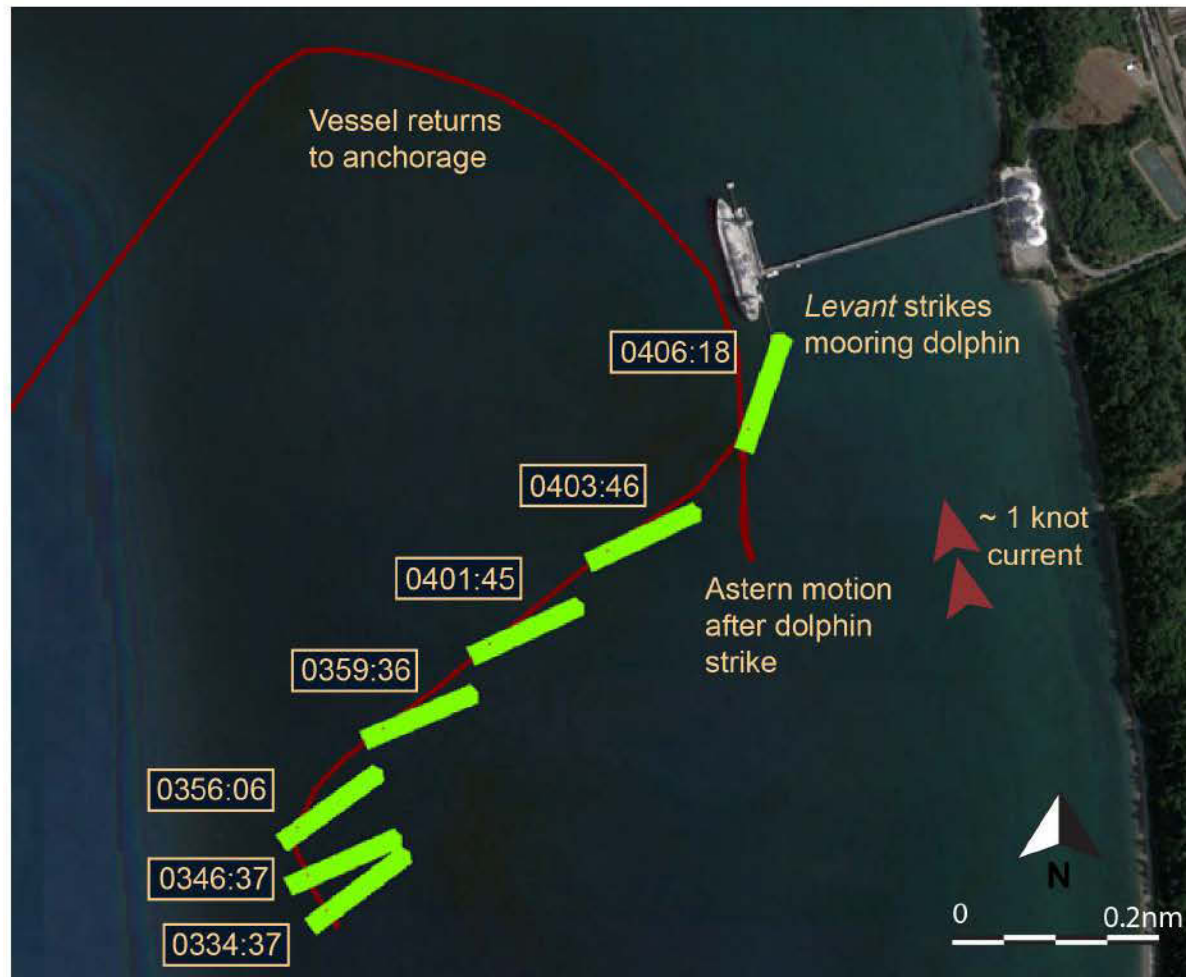
a position where they could see the wharf and south mooring dolphin. The fourth officer radioed the master that there was a 40-meter distance to the mooring dolphin, and the master relayed this distance to the pilot. After hearing this distance, the pilot ordered dead slow astern propulsion. The pilot asked for the distance to the wharf again, and he heard 10 meters as the reply over the radio. At 0406, the bosun announced over the radio the distance from the wharf was 5 meters before both he and the fourth officer moved further aft for personal safety. At that time, the heading of the *Levant* was 024 degrees with a speed of 4.3 knots, about 41 degrees off the dock alignment heading of 343 degrees.

The *Levanf's* positions as it moved from the anchorage to the Petrogas Wharf, based on automatic identification system (AIS) data. Vessel scale approximate; vessel at pier was not present at the time of the accident. (Background source: Google Earth)

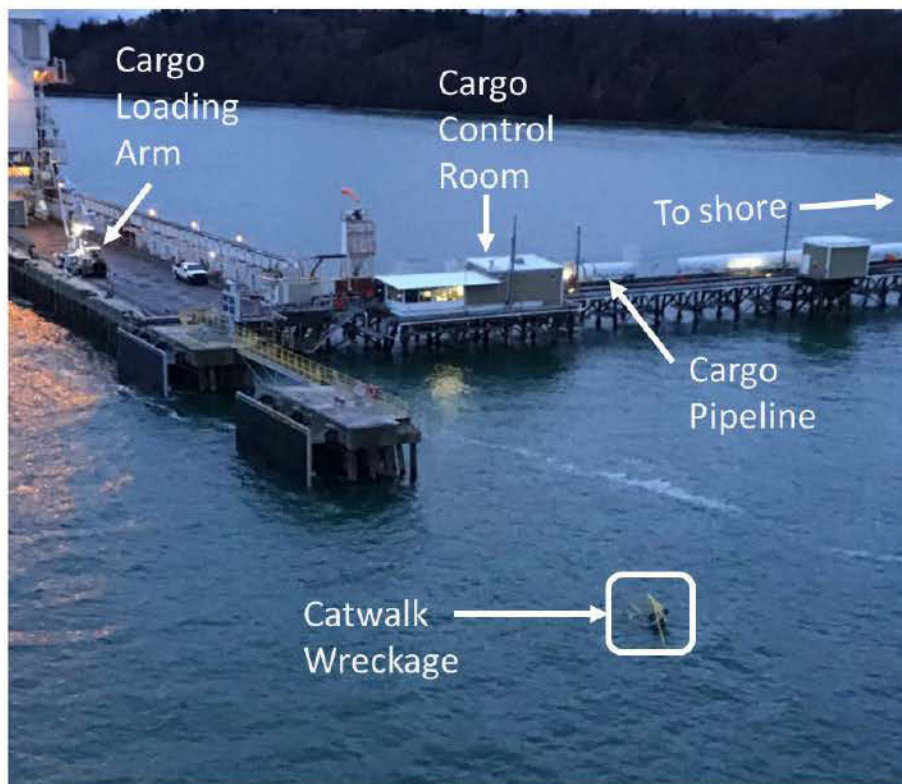
After the contact with the mooring dolphin, the *Levant* crew discovered that an empty forward ballast tank was taking on water. A subsequent damage assessment found four hull breaches below the waterline in the *Levant's* number one port ballast tank, and a crease approximately 40-60 inches long on the port bow. The estimated cost to repair the damage to the vessel was \$1.5 million. The south mooring dolphin and adjoining catwalk at the Petrogas Wharf were completely destroyed; the estimated replacement cost was \$6.75 million.

Postaccident photo of the Petrogas Wharf on the morning of December 15 with the catwalk and south mooring dolphin missing. (Source: US Coast Guard, annotated by NTSB)

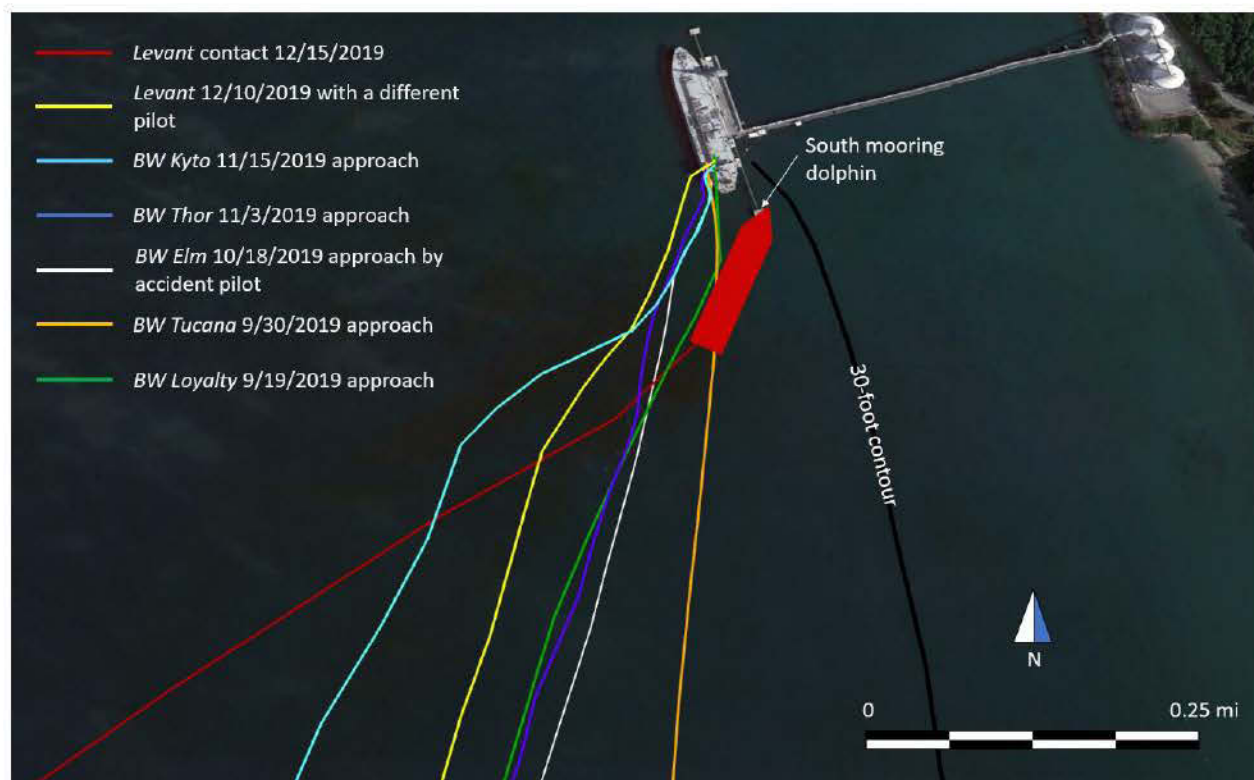
A sample of similar size liquefied petroleum gas carrier approaches to the Petrogas Wharf in the 90 days before the accident, including the accident pilot’s last docking of a similar size tanker at the Petrogas Wharf on October 18, 2019, was examined. All six approaches, including the *Levant’s* December 10 approach, were at a shallower angle than the accident docking. Additionally, all other approaches had less than 3 knots approach speed within 0.25 miles of the south mooring dolphin.

AIS tracks of all liquid petroleum gas carrier approaches to the Petrogas Wharf from September 19 to December 15, 2019. Included is the initial approach of the *Levant* to the wharf on December 10 (yellow line), and the accident pilot's last approach to the wharf on October 18 (white line). *Levant* scale approximate; vessel at pier was not present at the time of either approach. (Background source: Google Earth)
