PILOT BOARDING ARRANGEMENTS DEFICIENCY REPORT

Vessel: NAVIOS AMARANTH Master: MANRICO O. DAWSON
Date/Time: 05/22/2022 Pilot: DEISLER Inbound: Outbound:
Conditions: Day: Night: Wind: LT Sea: low Swell: Mod W Visibility: GOOD
Transfer Location: (sea/harbor) SEA Embarking: Disembarking:
Vessel Freeboard: 29m Vessel Draft: 10.5m Vessel Type: CONTAINER
Ladder Arrangements: Pilot Ladder Only: Combination Ladder: Side Port: Other:

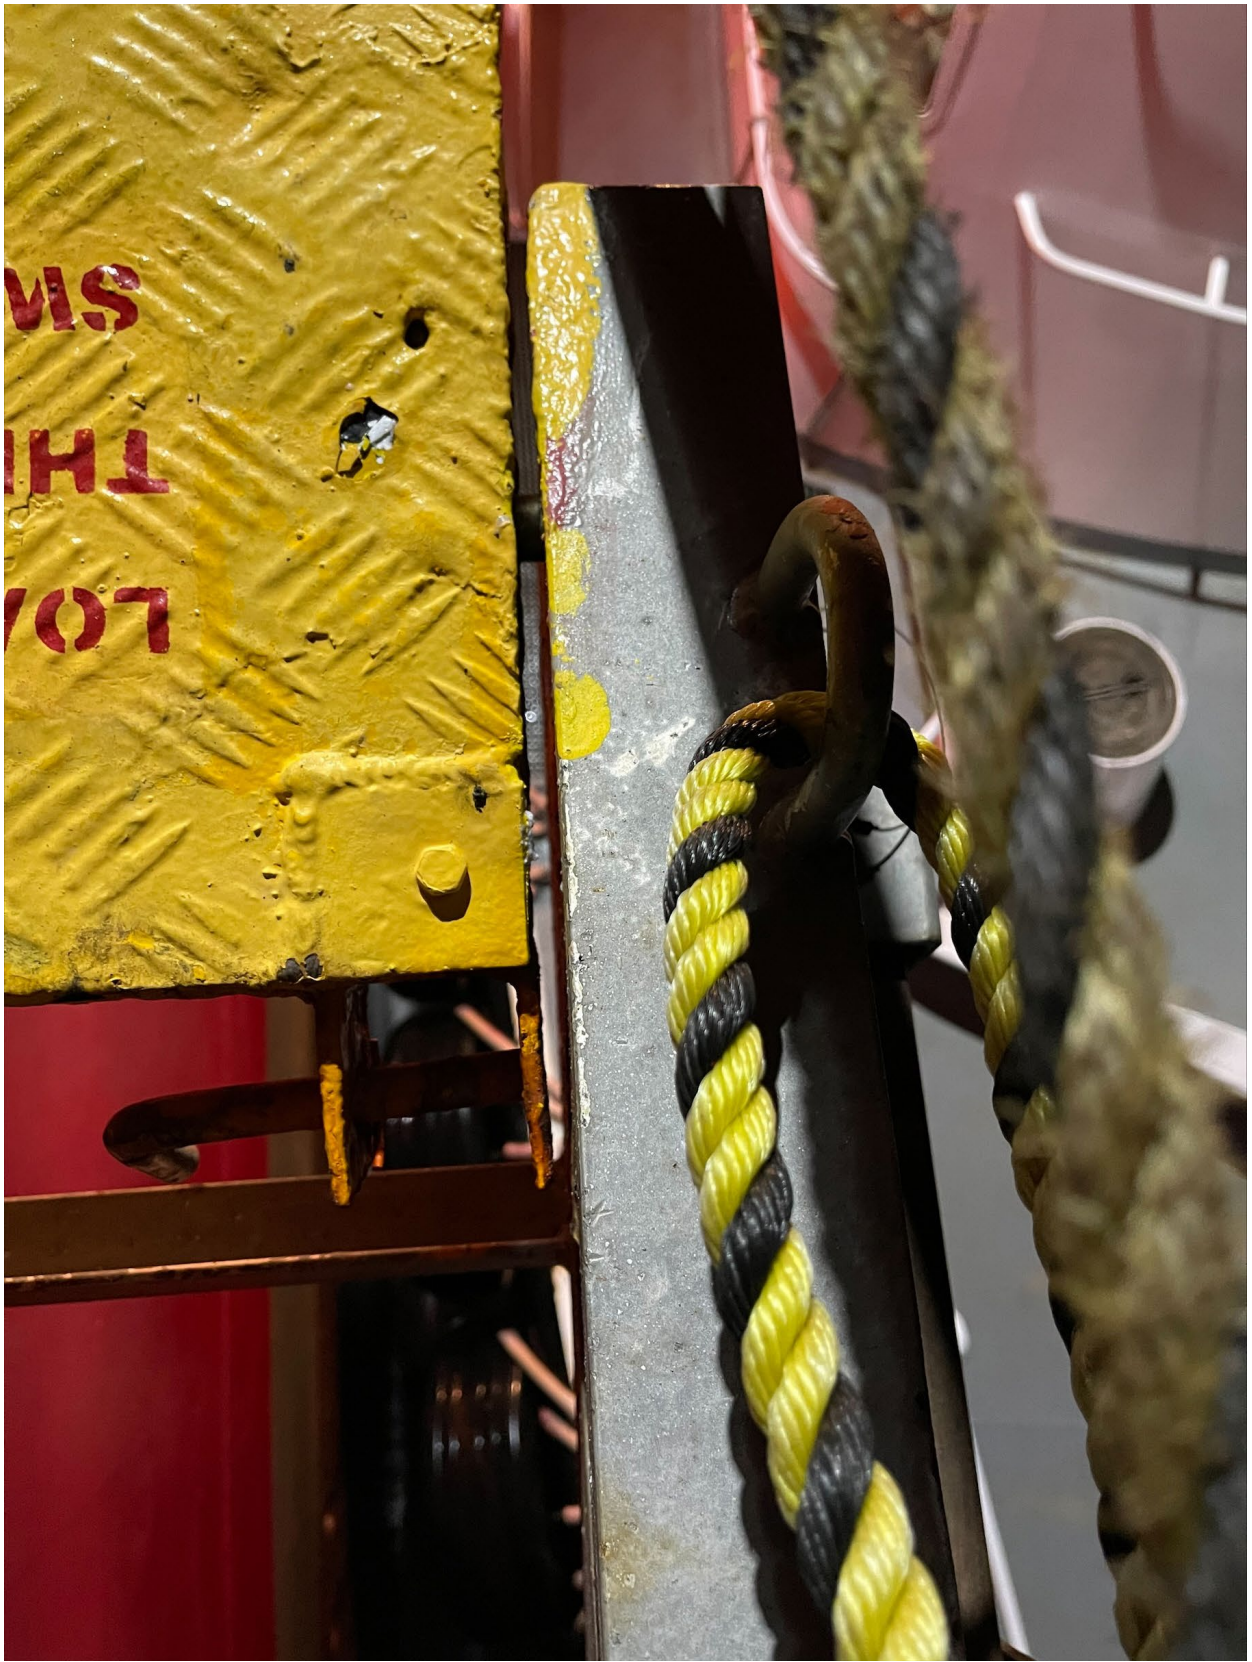
REMARKS: (attach photos if possible): ONE OF THE PLATFORM
PIN WAS NOT IN PLACE, AND 1/2" MANILA
ROPE WAS USED FOR MAN ROPE.
MATE ON DECK NOTIFIED.

PHOTO OF PLATFORM INC
