October 24, 2022

**CONDITION AND VALUATION SURVEY / APPRAISAL REPORT**

Vessel: P/V "DRAKE"

File No. 22032

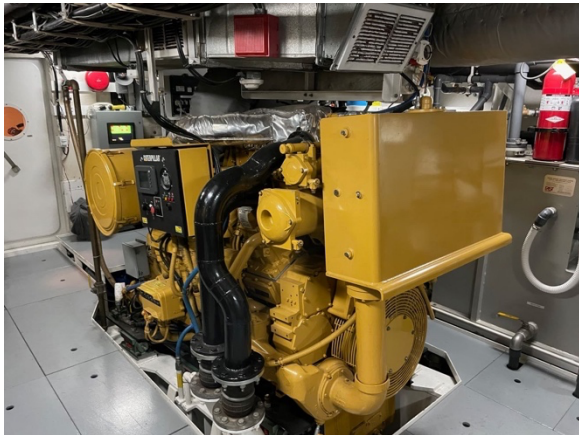
Port main engine

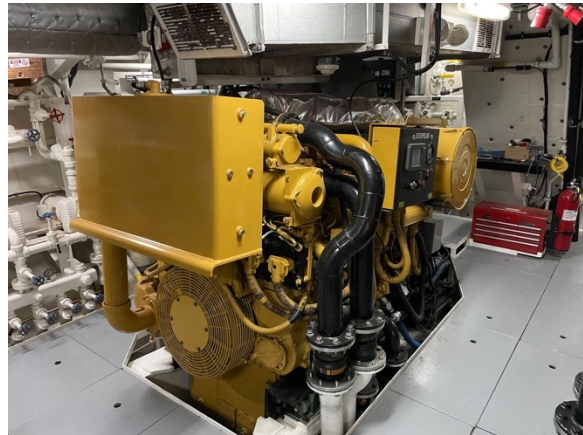
Starboard main engine

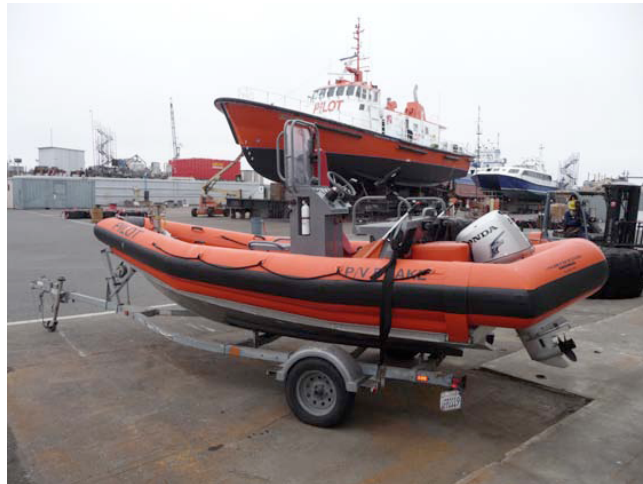
Rescue boat was equipped with a B:10 (old USCG size B-I) DC fire Extinguisher (tagged as inspected 3/2022), and a flare kit with (6) hand red (exp. 6/2022); (2) hand orange flares (exp. Jan & April 2022) and (5) aerial red flares (exp. 10/2024). There was a battery powered hand-held light that was marked as having batteries replaced 1/15/2019. However the light did not illuminate when tested (see Findings and Recommendations).

1. (2) Orange smoke flares in rescue boat expiration date Jan & April 2022. (6) hand red flares expiration date 6/2022. RECOMMEND renew expired flares.
2. The hand light in the rescue boat did not illuminate when tested. RECOMMEND repair or replace light and test it frequently.
1. The MOB Systems man overboard buoy mounted on the starboard aft rail was originally equipped with a solenoid operated switch from the pilothouse. The solenoid is now adrift and no longer functions, and the unit needs to be deployed manually. When I asked the operator that was on the vessel at the time of survey, he was not aware of this and did not know how to deploy the device manually. Also,
