October 24, 2022

**CONDITION AND VALUATION SURVEY / APPRAISAL REPORT**

VESSEL: P/V "CALIFORNIA"

File No. 22031

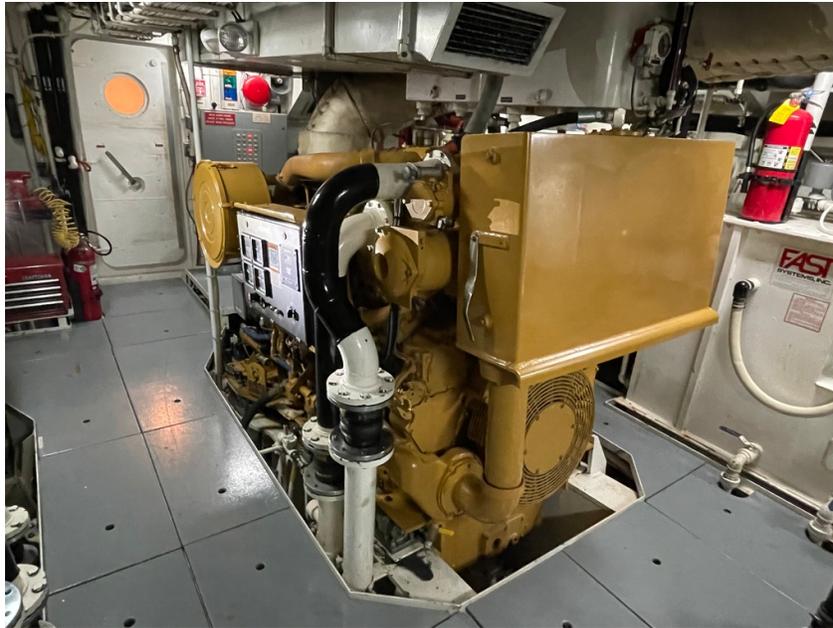
Port main engine had top end overhaul at 35,332 hours on 12/11/2009

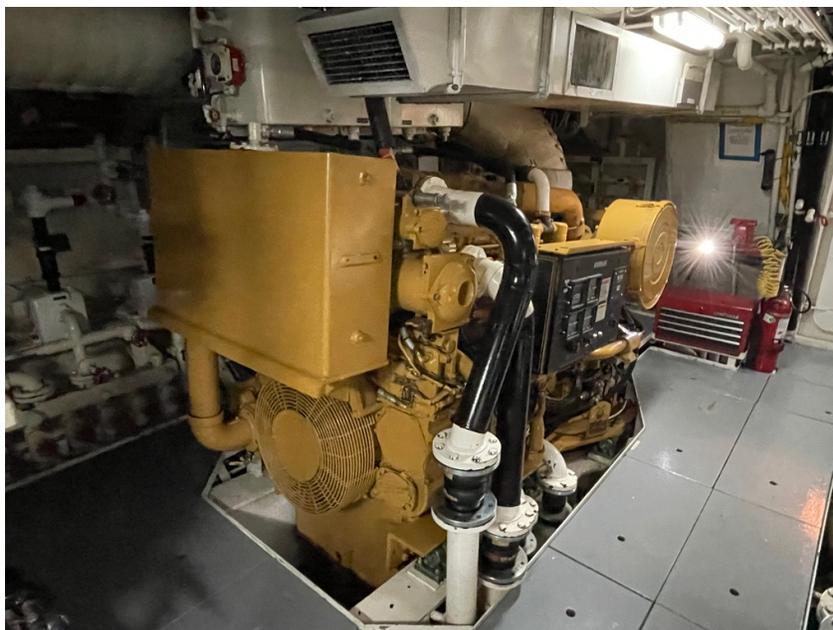
Starboard main engine had top end overhaul at 35,333 hours on 12/11/2009

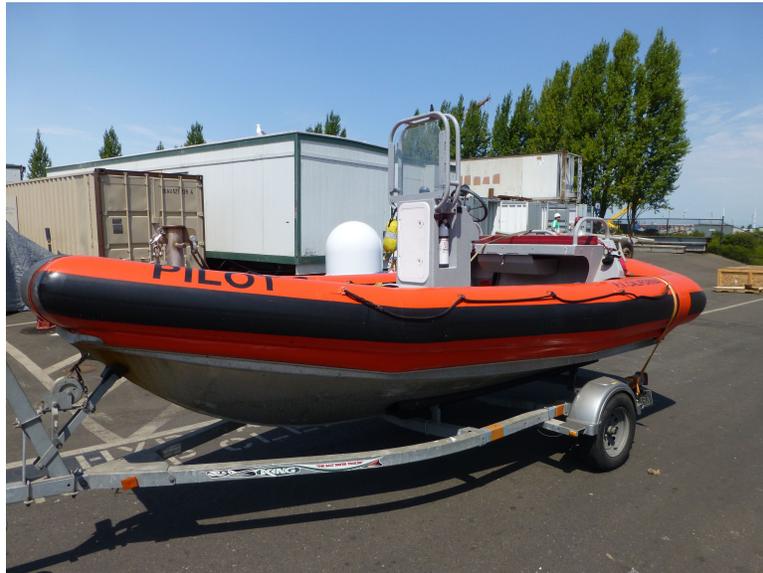
Rescue boat was equipped with a B:10 (old USCG size B-I) DC fire Extinguisher (tagged as inspected 2/2022), and a flare kit with (4) hand red (exp. 11/2024); (3) hand orange flares (exp. 10/2024) and (5) aerial red flares (exp. 10/2024)
