September 12, 2024

CONDITION AND VALUATION SURVEY / APPRAISAL REPORT

VESSEL: "PITTSBURG"

File No. 24011

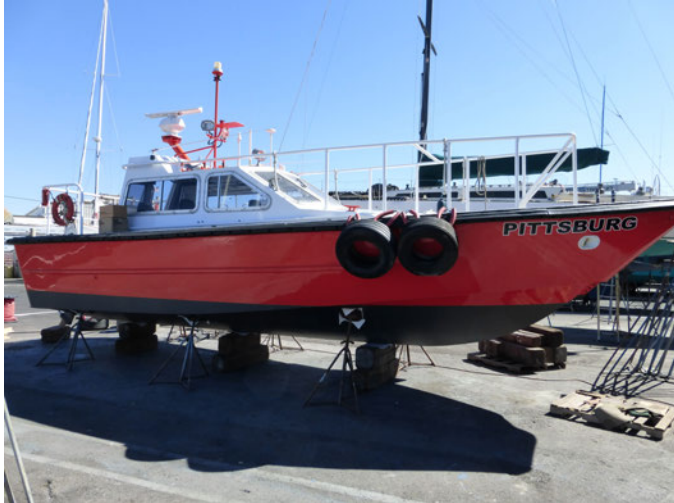
(Photo from prior survey)
