Agenda Item 11A: KONA TRADER IRC Report Attachments

M/V KONA TRADER APPROACH TO PORT OF STOCKTON – MARINE EXCHANGE AIS DATA

KONA TRADER PORT OF STOCKTON BERTH 12/13
DOI Sept 25, 2024

**MISLE Incident Investigation Report
For
KONA TRADER Allision**

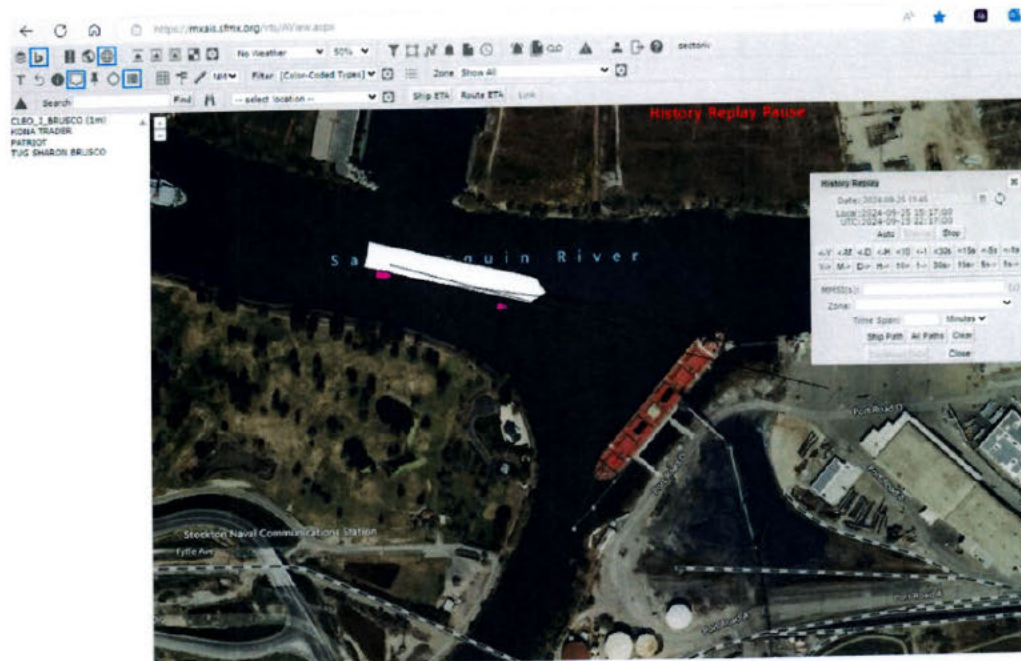
1. Time: 1517 local
2. KONA TRADER speed: 1.6 knt
3. Tug Positions: SHARON BRUSCO – starboard quarter, PATRIOT – starboard bow, CLEO BRUSCO – port bow

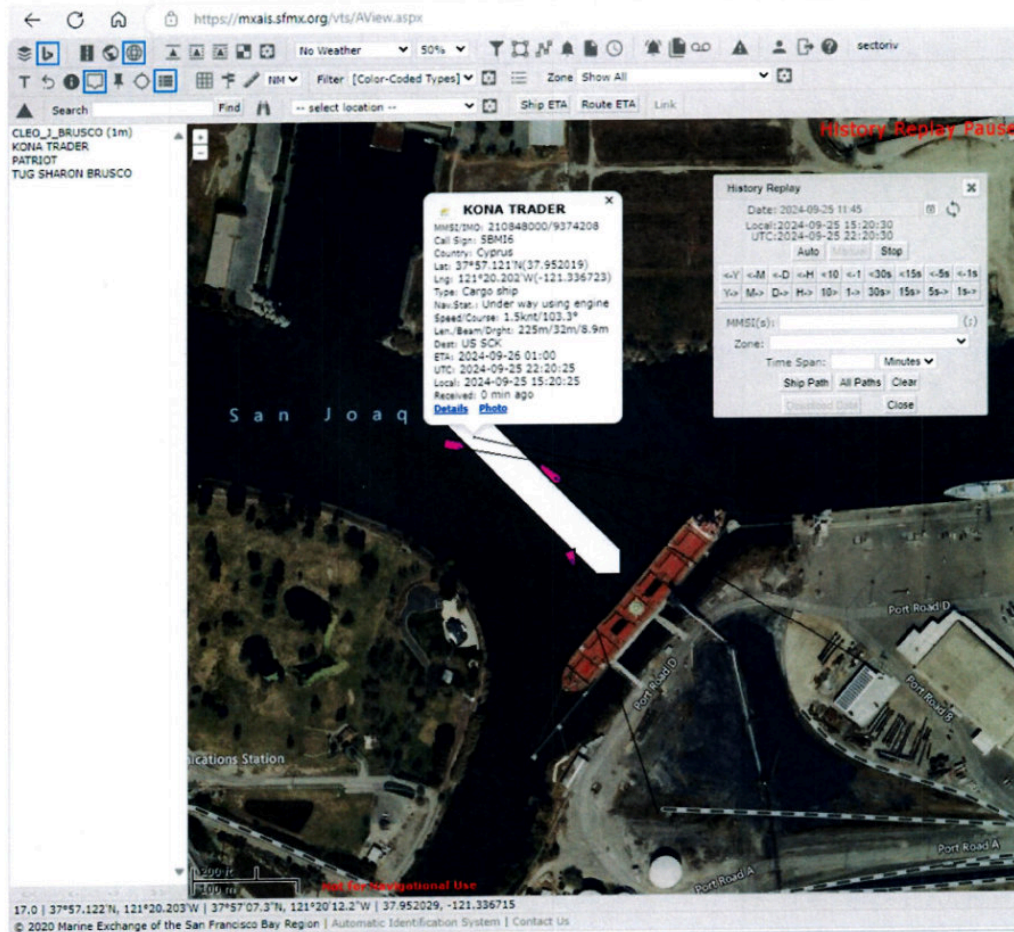
1. Time: 15:20:30 local
2. KONA TRADER speed: 1.5 knt

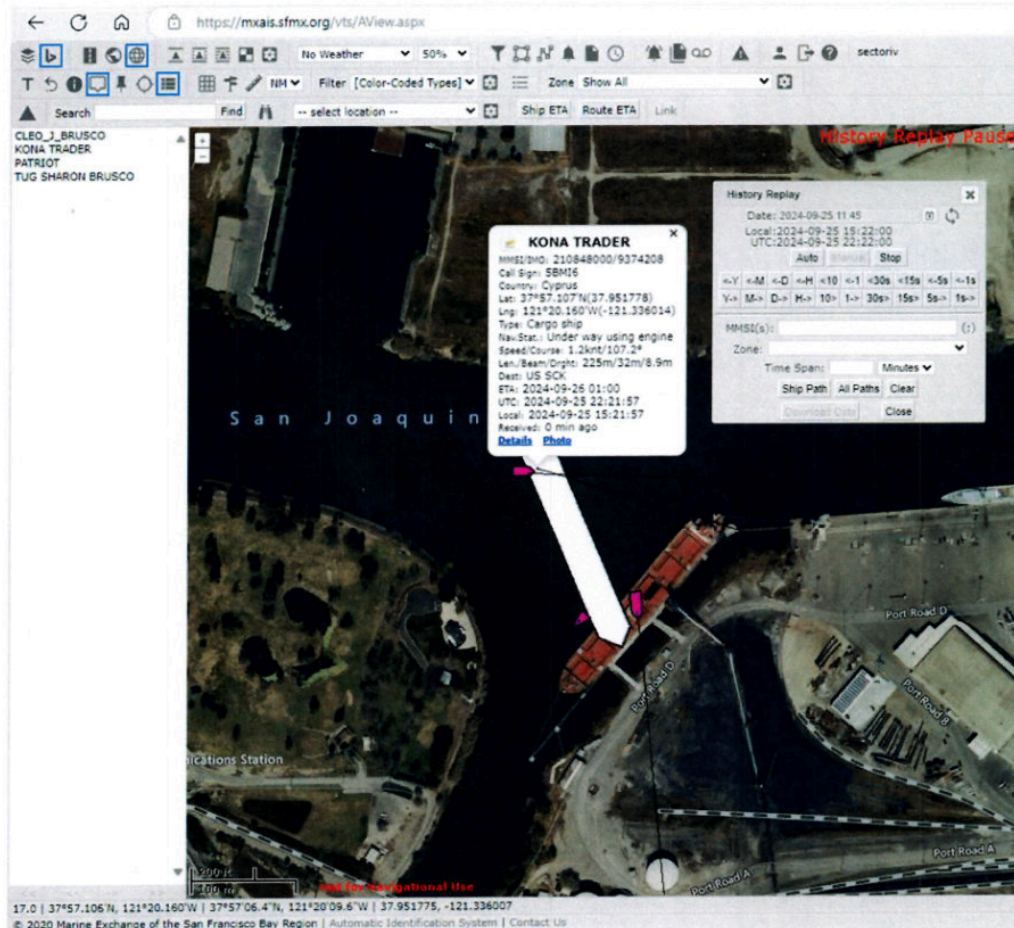
1. Time: 15:22 local (estimated time of allision)
2. KONA TRADER speed: 1.2 knt

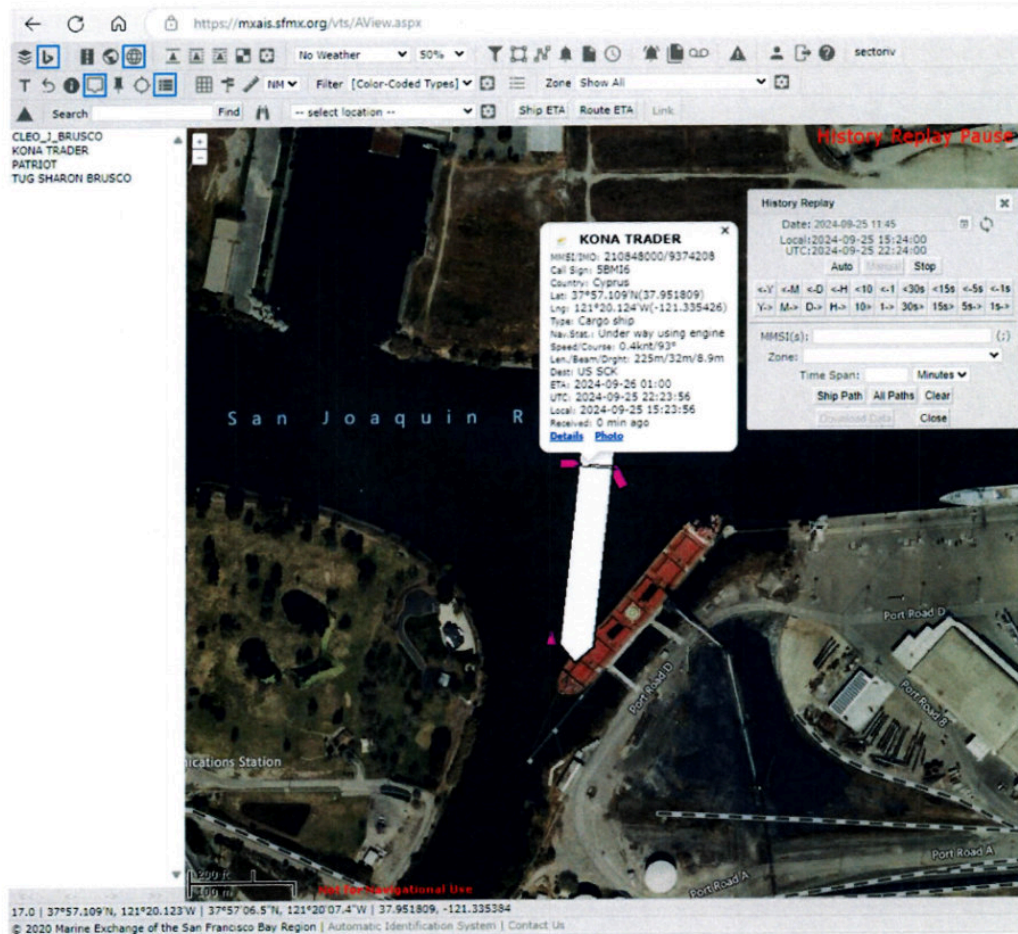
1. Time: 1524 local
2. KONA TRADER speed: 0.4 knt

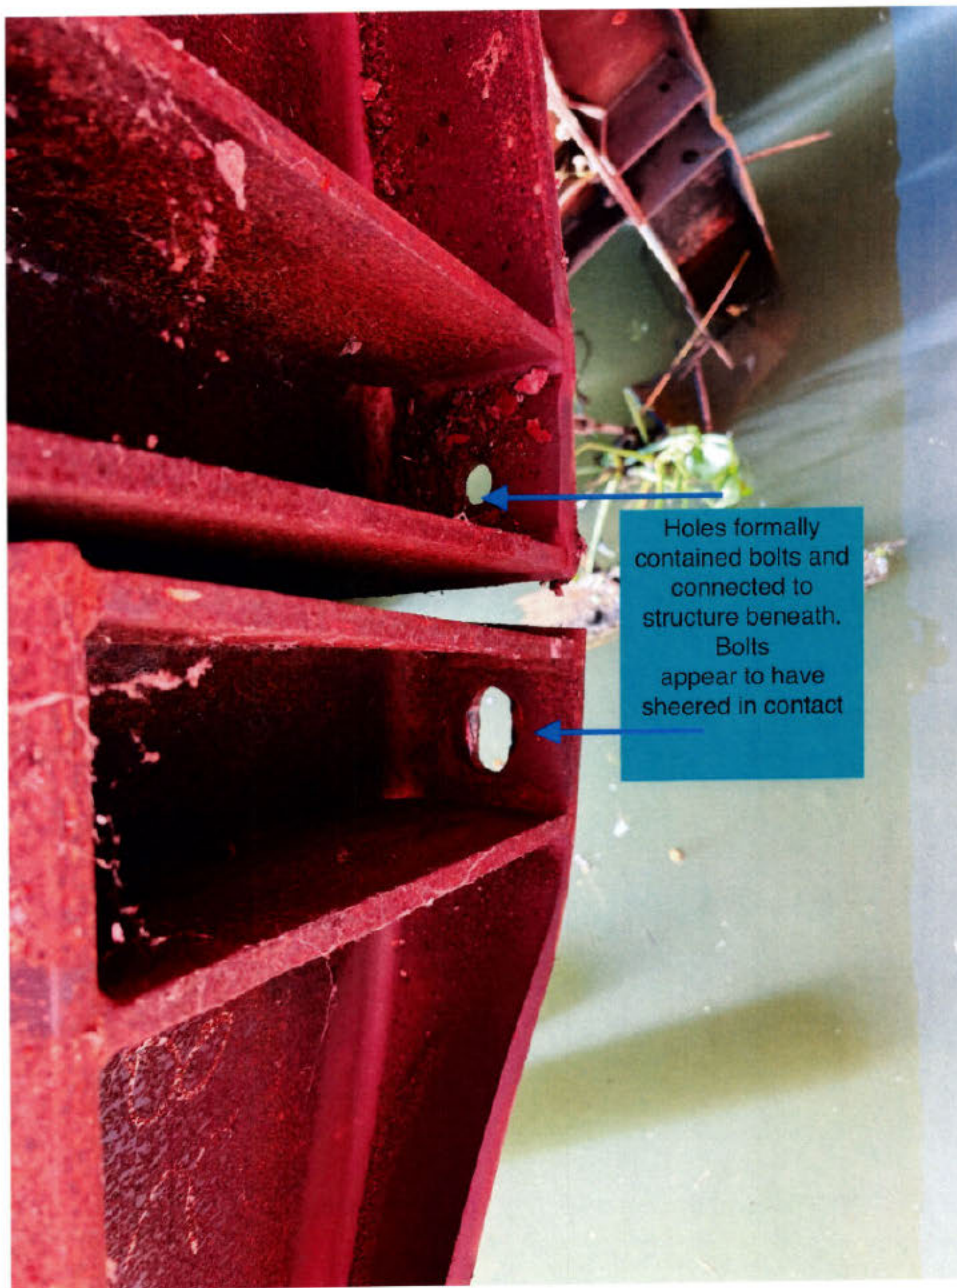
Bolt holes in horizontal structure. Construction details of pier indicate these holes held bolts that appeared to have been sheered off due to ship contact. Vertical structure, shown upper right, was push out 45deg from original position.

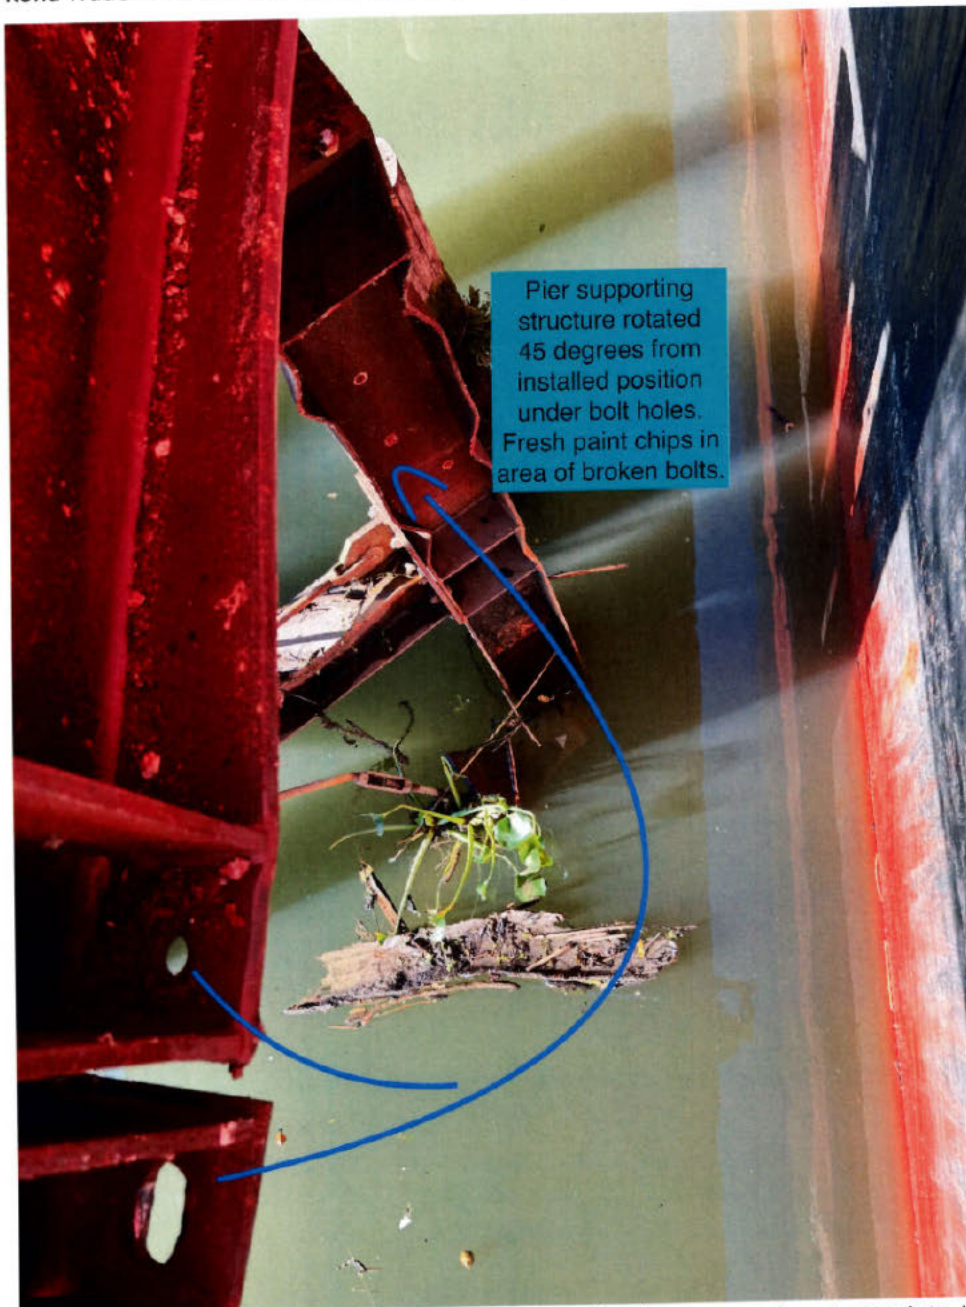
KONA TRADER PORT OF STOCKTON BERTH 12/13
DOI Sept 25, 2024

Photo shows what appears to be area of impact. It also shows several contact points. It is unclear to the commission investigator if the Kona Trader struck the dock several times, or the additional areas of impact are from prior ship contact. Paint chips indicate one area of contact was recent.

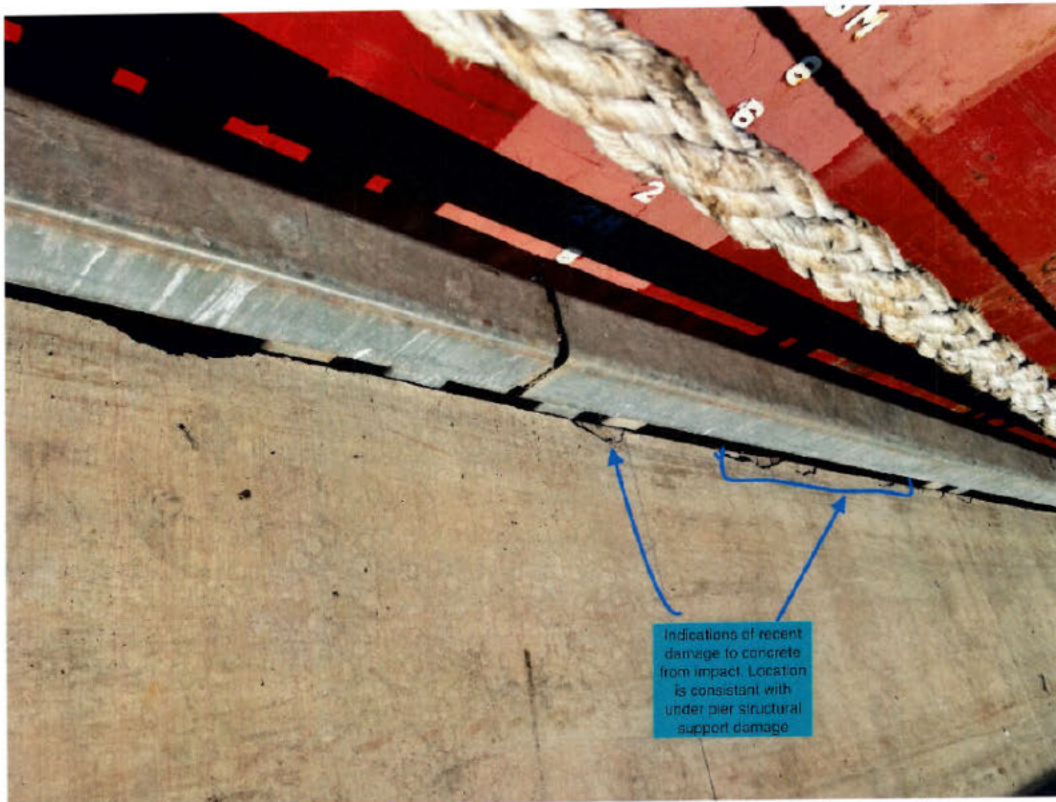
KONA TRADER PORT OF STOCKTON
DOI Sept 25, 2024

Indications of recently fractured concrete on the top surface and water side pier edge were found. Location of the concrete damage is directly above what appears to be the area of contact with the steel support structure under the pier.

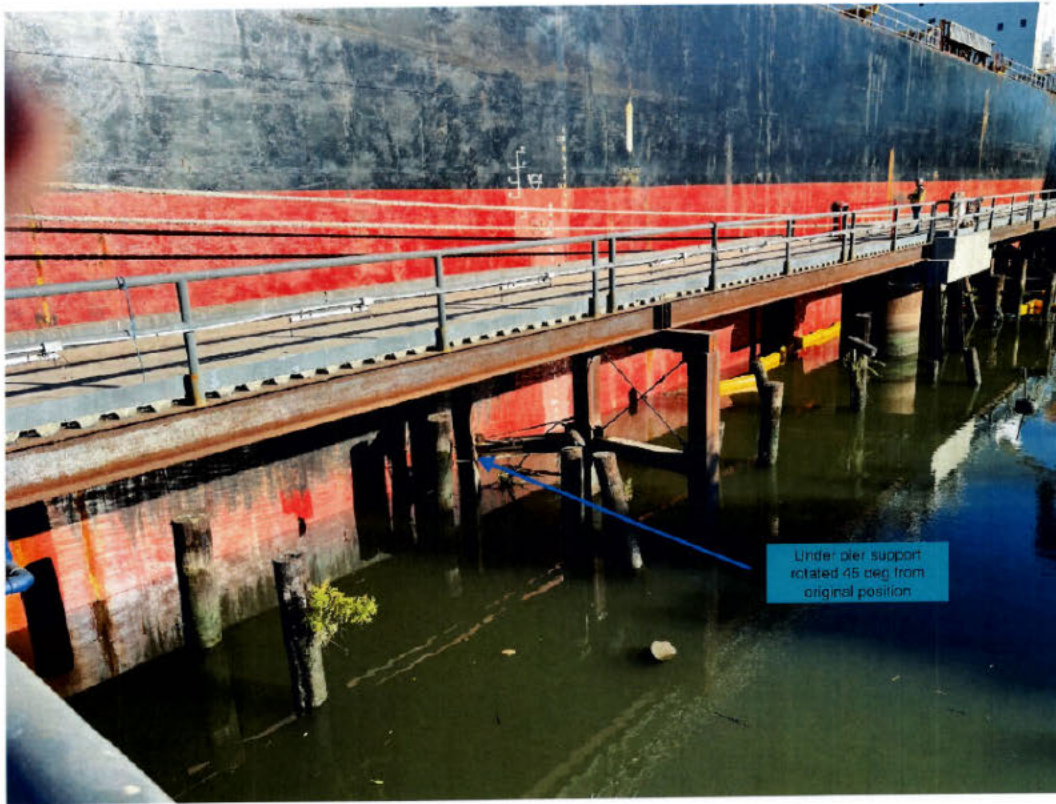
KONA TRADER PORT OF STOCKTON BERTH 12/13
DOI Sept 25, 2024

Damaged area shown in this photo is same area as show in photo 2, attachment 4, but from a different angle. Note the broken tension rods. This steel pier support detail is repeated several times under the length of the pier. The location shown above is the only one of these details found damaged.

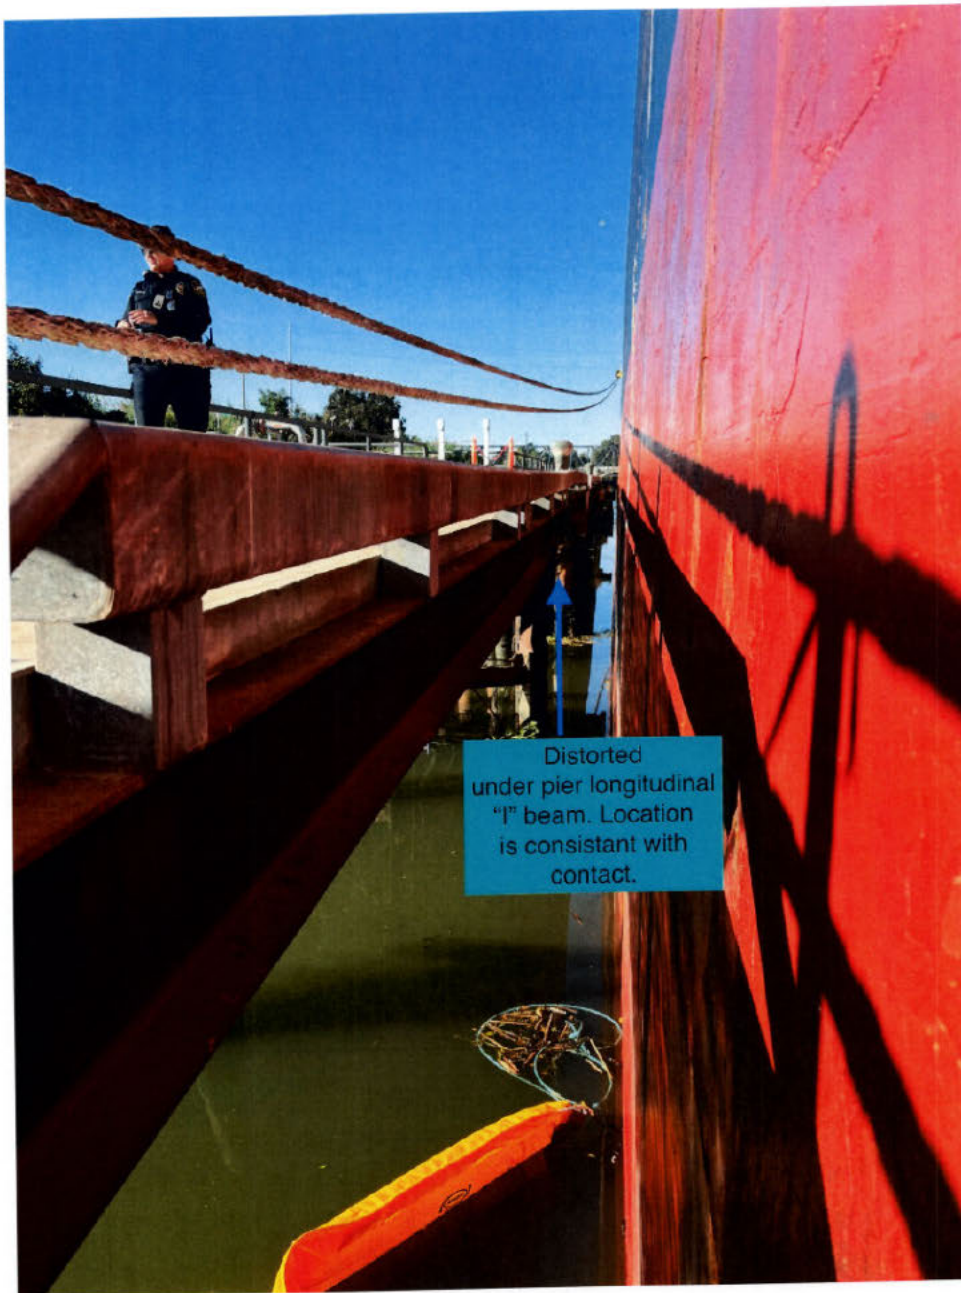
KONA TRADER PORT OF STOCKTON BERTH 12/13
DOI Sept 25, 2023

Distorted
under pier longitudinal
"I" beam. Location
is consistent with
contact.

The concrete pier deck is supported by several "I" beams. The one above is supports the ship side of the pier. It shows damage to the flange and web over 10' of length. The location is consistent with the area of contact.

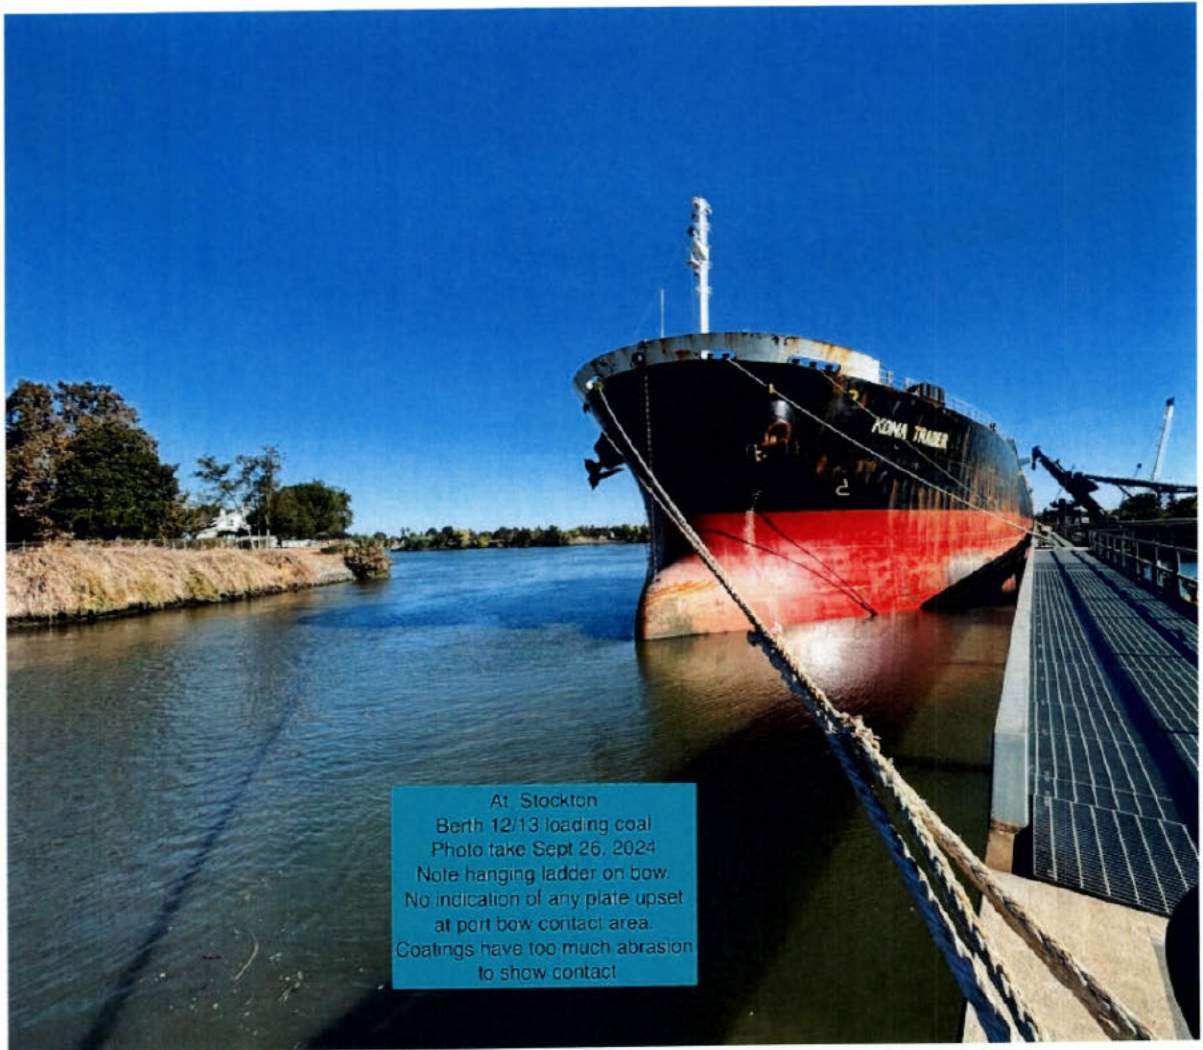
Kona Trader Port of Stockton Dof | September 25, 2024

Damage to coatings on bulbous bow were consistent with the age of the hull coatings. No conclusions could be draw by commission investigator of the impact location on the ship through inspecting the bow.
