**INCIDENT REVIEW COMMITTEE
INVESTIGATION REPORT**

**REPORT OF THE DOCKING OF THE M/V KONA TRADER AT
THE PORT OF STOCKTON, BERTH 12/13, ON SEPTEMBER 25, 2024
PILOT: CAPTAIN MATTHEW STEVENS**

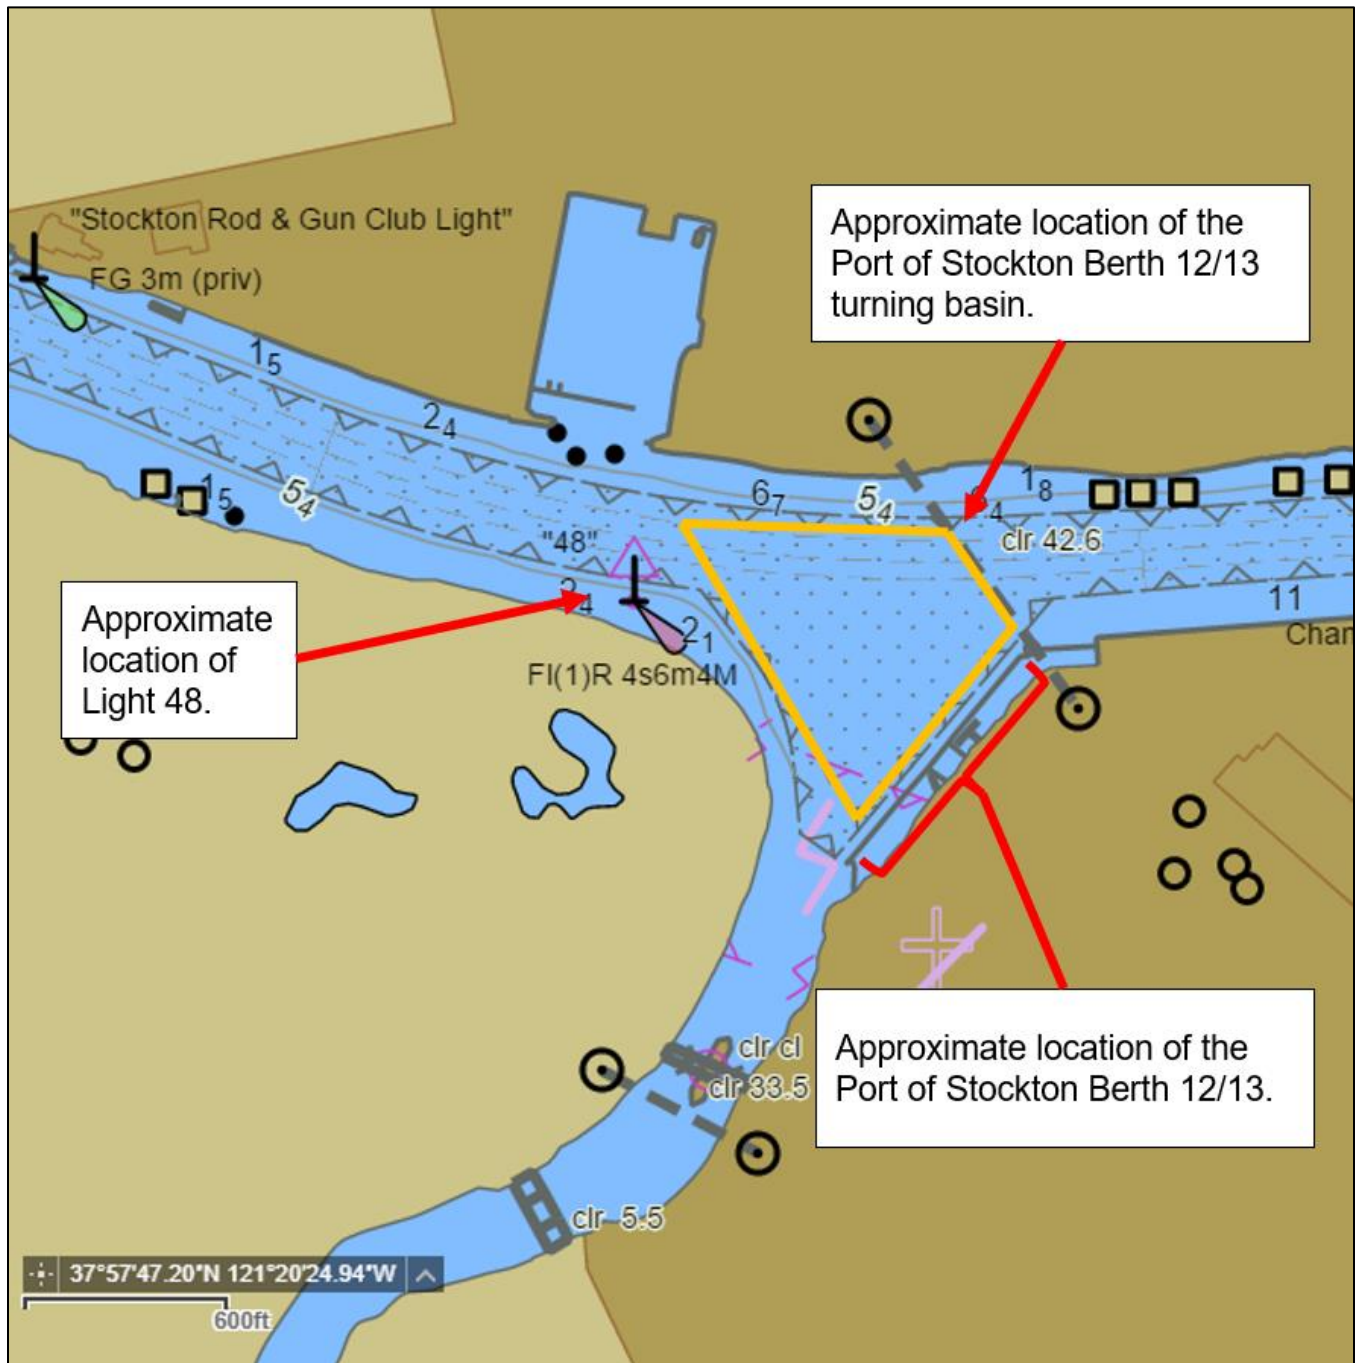
Figure 1. Port of Stockton Turning Basin with Approximate Annotations by the IRC. Chart Source: Office of Coast Survey, National Oceanic and Atmospheric Administration, U.S. Department of Commerce at <https://www.nauticalcharts.noaa.gov/enonline/enonline.html>.

As Figure 1 illustrates, the turning basin at Berth 12/13 is very tight. When turning vessels as large as the KONA TRADER in this basin, the maneuvering is very restricted, so utmost caution and precision are required to avoid contact with the channel's edge or the dock. Incorrectly estimating one distance may result in grounding or damage to the propeller; miscalculating another might lead to unintended contact with the dock (as seen in this case).
