SURVEY REPORT

Project No. CTMT001

ON-HIRE CONDITION, BUNKER, AND VALUATION SURVEY

POLLUTION RESPONSE VESSEL "MELISSA C"
1,335GRT

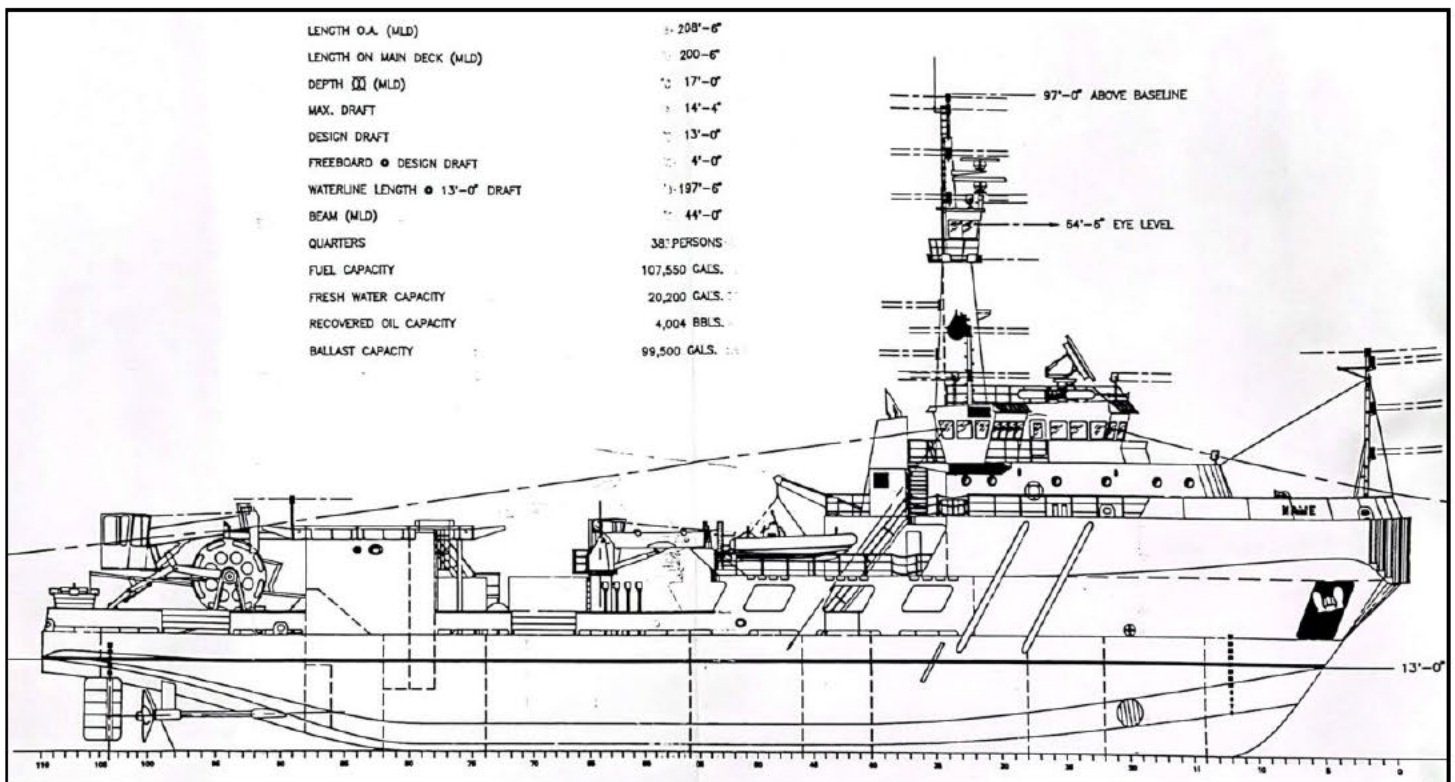
Picture 1: General Layout

The hull, where visible, appeared in good condition with no heavy scraping, major gouges, indentations or doubler plates observed. Paint coating was observed to be in good condition and intact throughout, with only mild spot corrosion sighted in isolated areas.

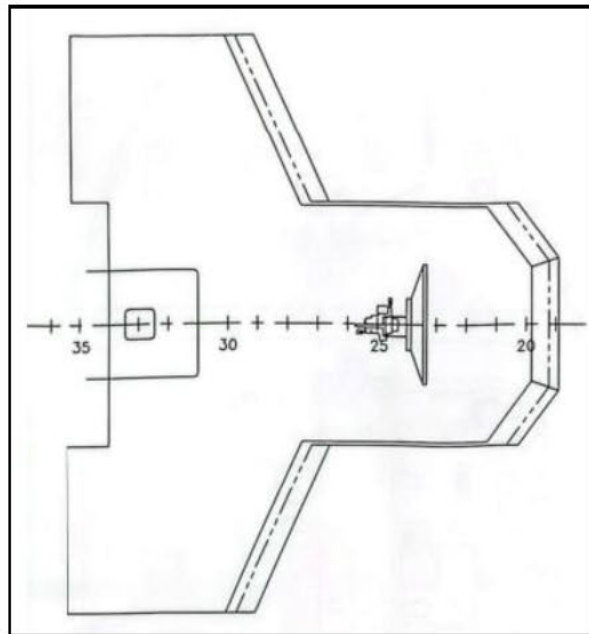
Picture 2: 04 Level – Pilot House Top

All fitted items, including railings, ladders, lights and associated equipment, visually appeared to be in a satisfactory condition with no damage or deformation noted. Paint coating satisfactory and corrosion minimal.

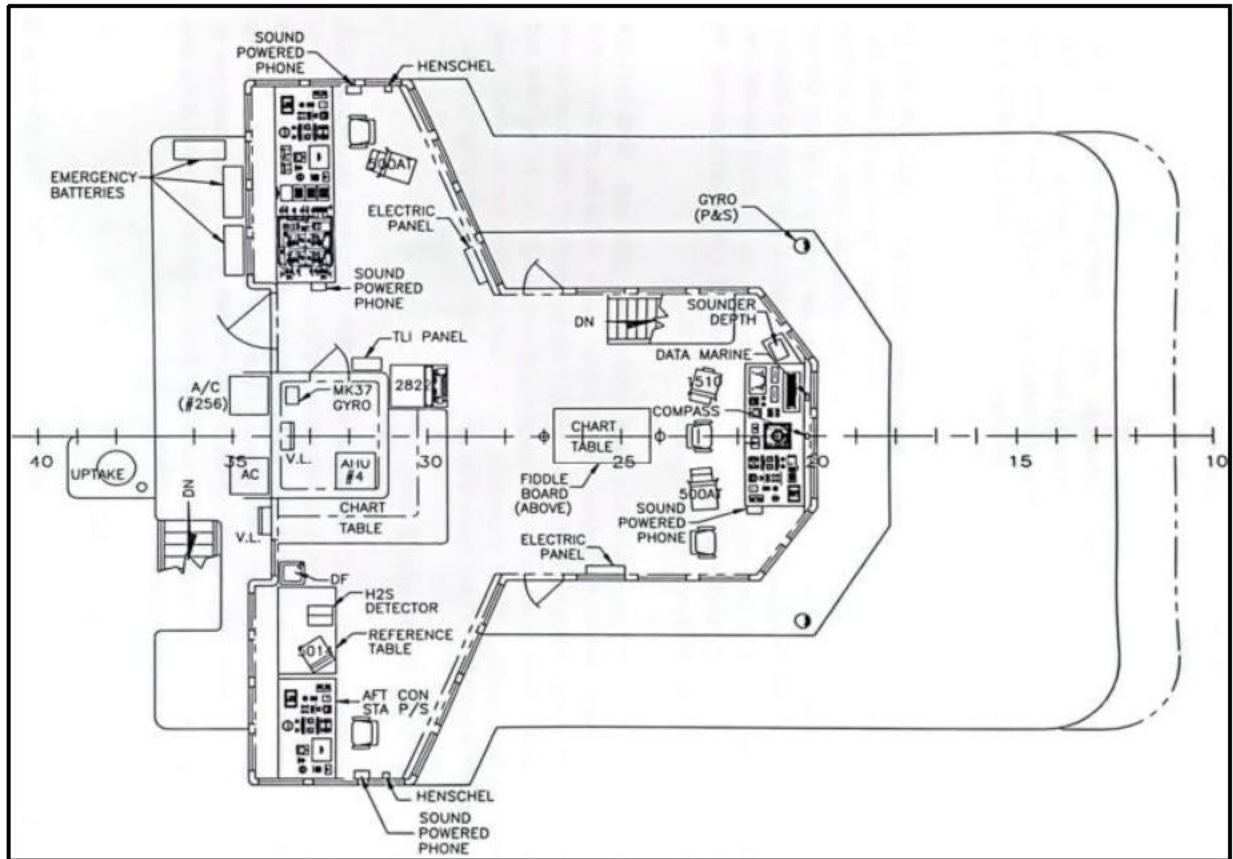
Picture 3: 03-Level – Pilot House

External decks were observed to be in satisfactory condition with good paint coating and minimal corrosion.

All fitted items, including railings, ladders, lights and associated equipment, visually appeared to be in a satisfactory condition with no damage or deformation noted.

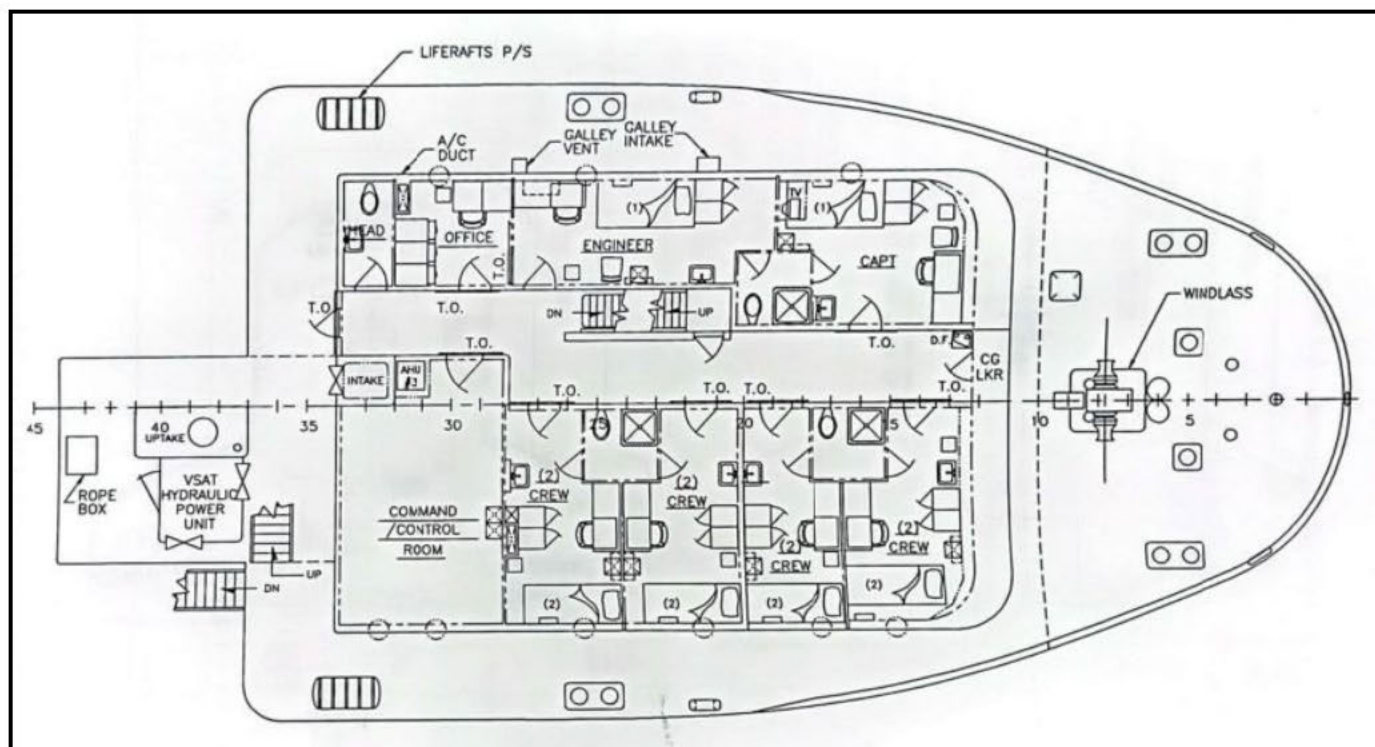
Picture 4: 02-Level – Foc'sle Deck

All fitted items, including railings, ladders, lights and associated equipment, visually appeared to be in a satisfactory condition with no damage or deformation noted. Internal spaces were noted as clean and well lit, with no immediate observable damage to furnishings.

Deck lighting was fitted throughout externally, along with multiple vents. No damage, in way of heavy scraping, gouging or deformation was observed to the visible plating on the bow. No doubler plates were observed. Paint coated was noted as being in good condition with full coverage. Corrosion noted as minimal.

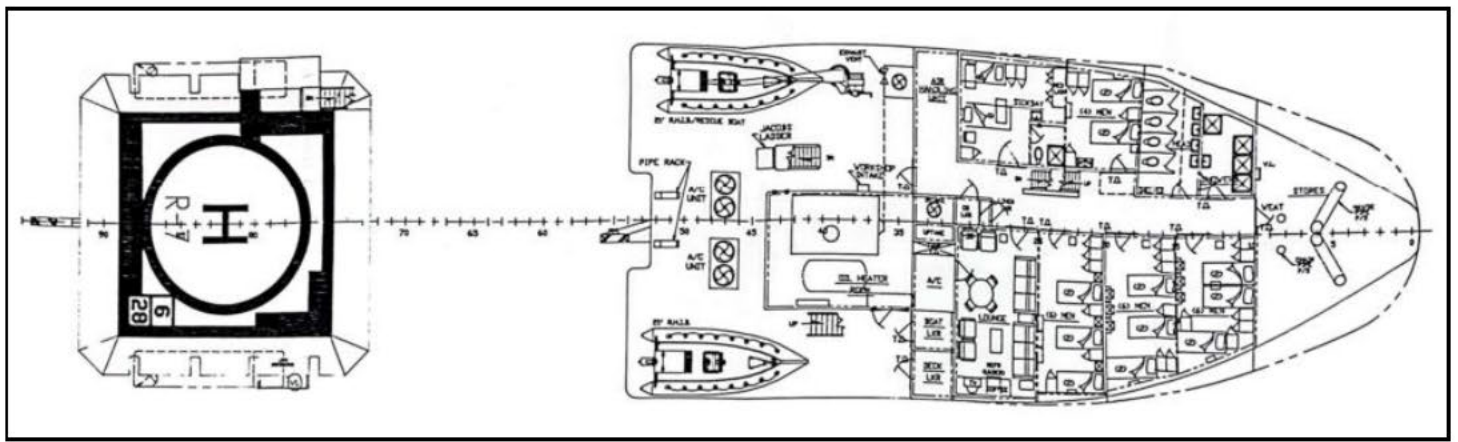
Picture 5: 01-Level – Quarters and Helo Deck

All fitted items, including railings, ladders, lights and associated equipment, visually appeared to be in a satisfactory condition with no damage or deformation noted. Internal spaces were noted as clean and well lit, with no immediate observable damage to furnishings.

Deck lighting was fitted throughout externally, along with multiple vents. No damage, in way of heavy scraping, gouging or deformation was observed to the visible plating. No doubler plates were observed. Paint coated was noted as being in good condition with full coverage. Corrosion noted as minimal. The helo deck was well coated with a layer of grit for additional friction.

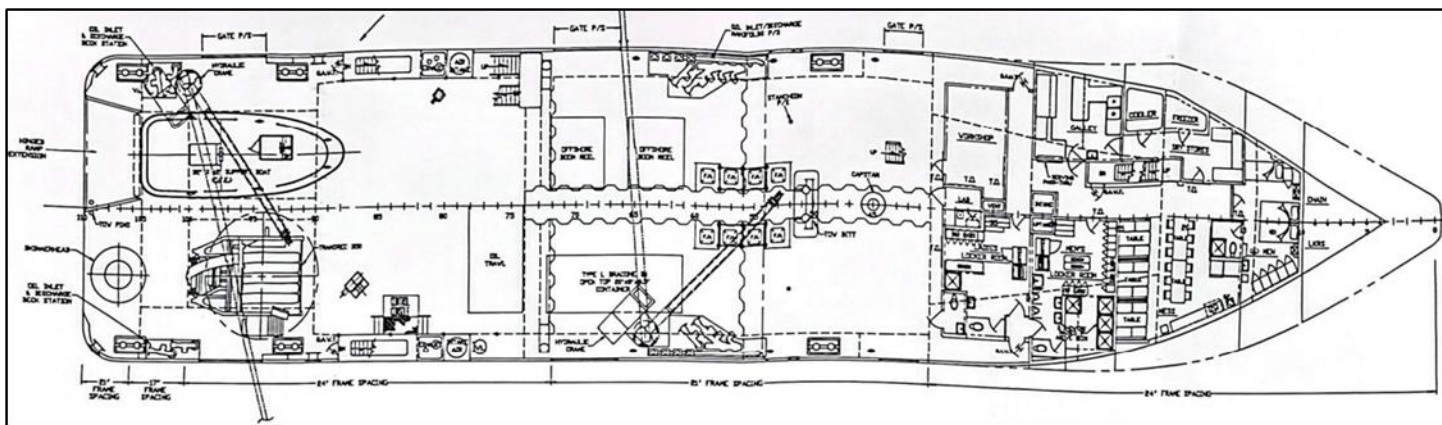
Picture 6: Main Deck

The aft deck was observed to be neat and clean. Save-alls were empty of liquid. All equipment on the aft deck, including cranes, winches, and capstans, was tested and found operational. No excessive leaking of hydraulic oil was observed. All fitted items, including railings, ladders, lights and associated equipment, visually appeared to be in a satisfactory condition with no damage or deformation noted. [Photograph Nos. 158-160]

Deck lighting was fitted throughout externally, along with multiple vents. No damage, in way of heavy scraping, gouging or deformation was observed to the visible plating. No doubler plates were observed. Paint coated was noted as being in good condition with full coverage. Corrosion noted as minimal.

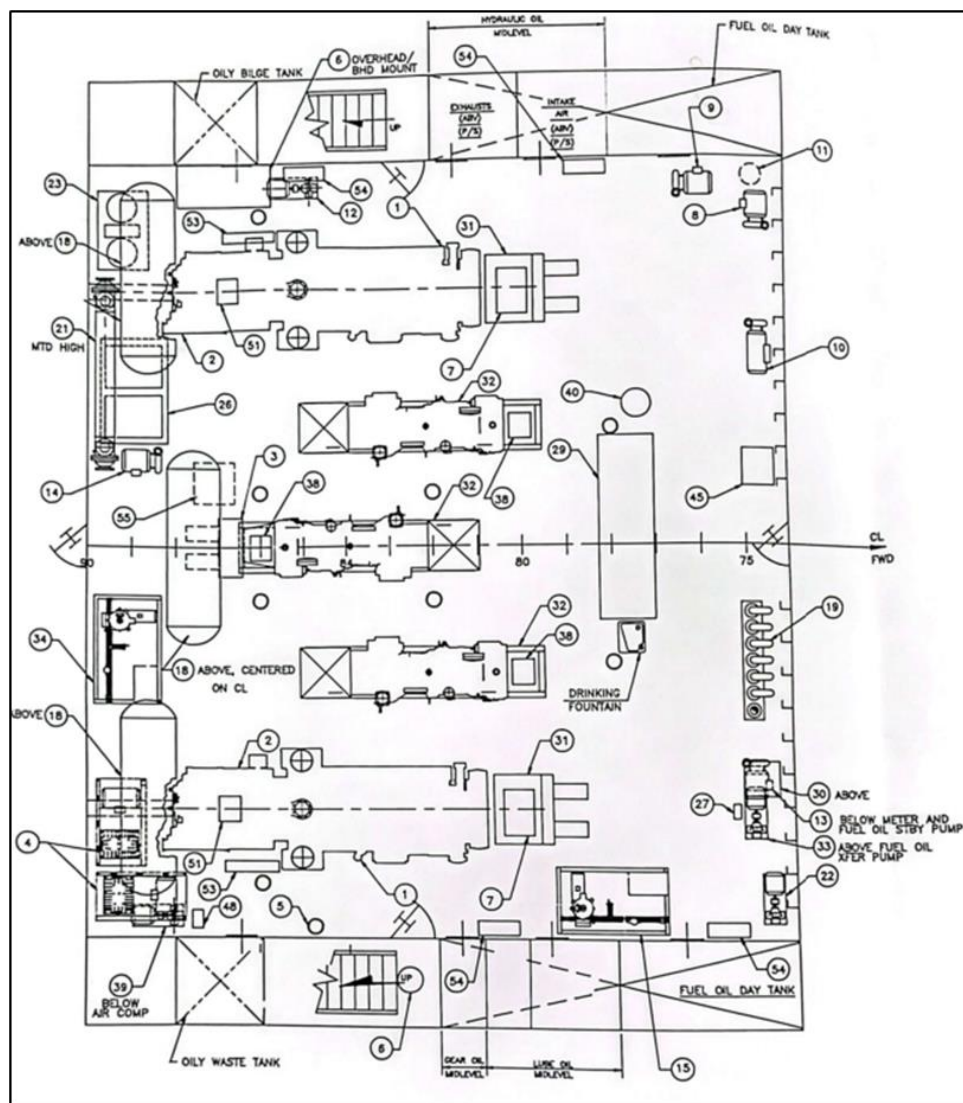
Picture 8: Engine Room

The engine room was observed to be clean and tidy with all equipment generally sound. Lighting and ventilation were good. Floor plates were fitted throughout. All equipment was visually observed to be in a satisfactory and sound condition.
