From: Port Agent <portagent@sfbarpilots.com>
Sent: Tuesday, April 28, 2020 9:42 AM
To: Garfinkle, Allen@BOPC
Cc: Anne McIntyre
Subject: Champion Concept

IMAGES FOR CASE 20-0057

On 04/28/2020 at approximately 0100 hours, the vessel Champion Concept hit the northeast section of Dock 9 while shifting from Dock 8 to Dock 9. The dock sustained minor damage to the wooden bull rails and the ship sustained a large scrape on the starboard side stern. The pilot of the ship was Sam D'Aloisio (Unit #42).

MISLE Incident Investigation Report For CHAMPION CONCEPT Allision

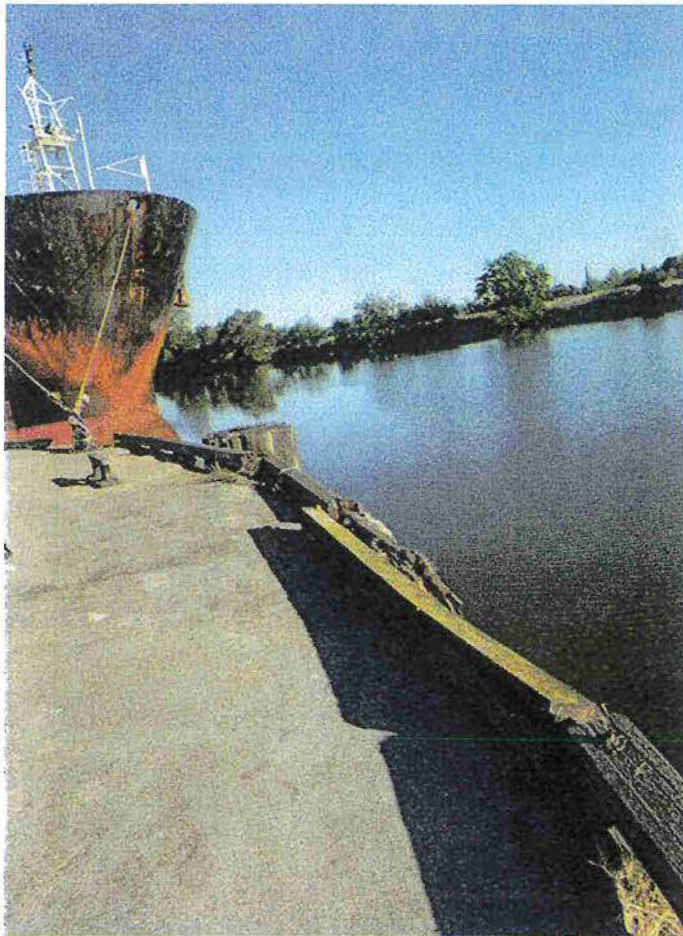
Photo #: 7

DOCK 9 NORTHEAST DAMAGE

I arrived to dock 9 and inspected the apron of the point of dock 9 and found a section of about 20 feet of broken wooden bull rail and crushed concrete. Able Body Seaman (Al Manuel Ayala) led me to the stern of the vessel Champion Concept and pointed out an area of the starboard side hull which had a deep scrape with some denting on the starboard side hull of the ship approximately 10 feet long and 1 foot tall.
