**BOARD OF PILOT COMMISSIONERS FOR THE  
BAYS OF  
SAN FRANCISCO, SAN PABLO, AND SUISUN**

**INCIDENT REVIEW COMMITTEE  
INVESTIGATION REPORT**

**REPORT OF THE DOCKING OF THE P/V STAR PRINCESS AT  
SAN FRANCISCO (PIER 27), ON OCTOBER 2, 2019  
PILOT: CAPTAIN ORRIN FAVRO**

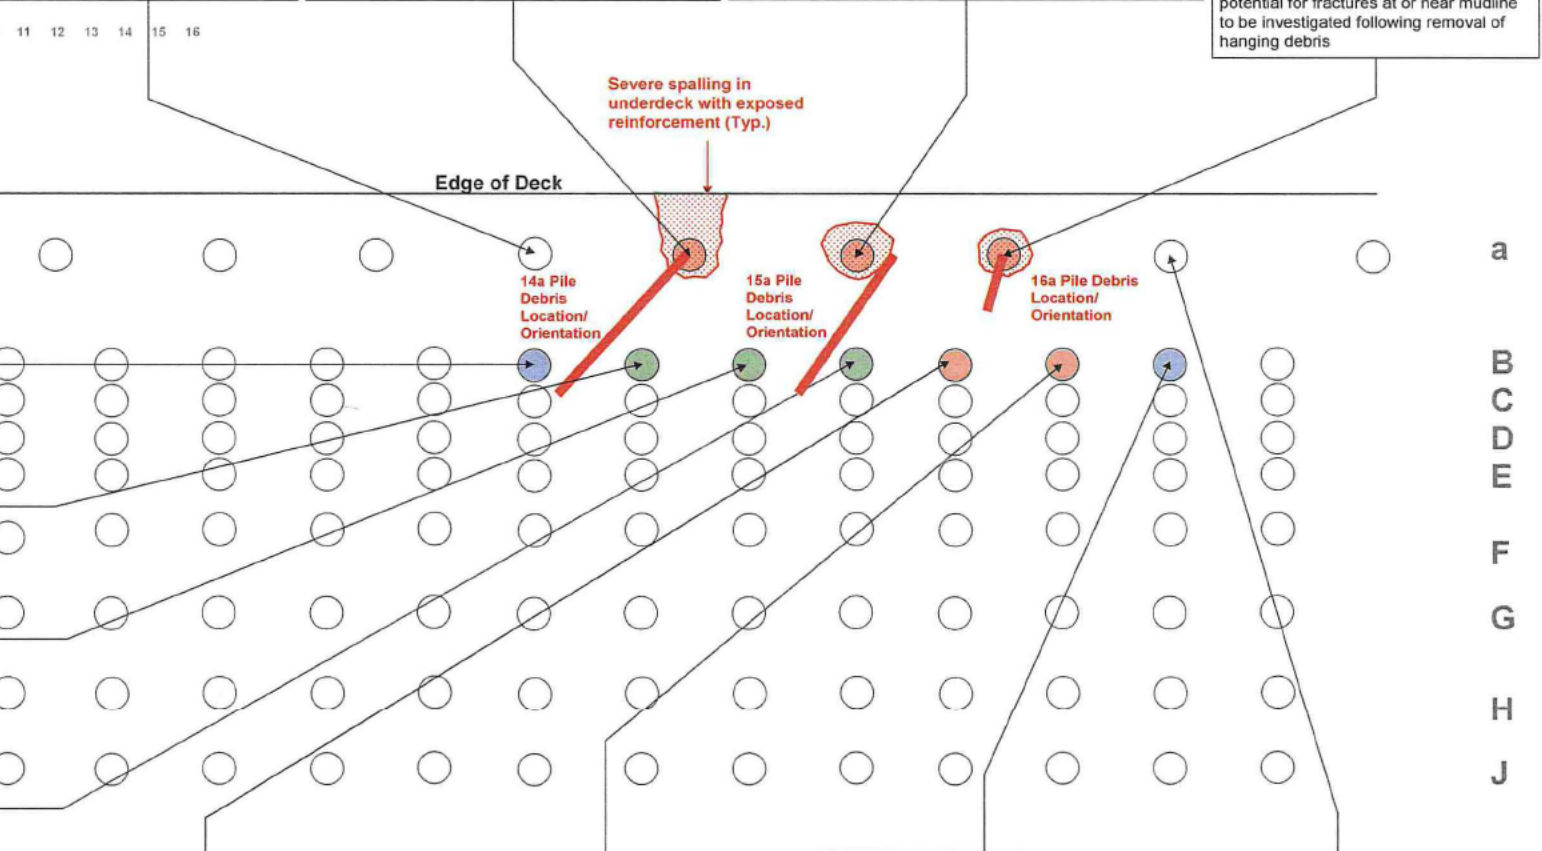
UW Photo Location - Marine growth over erosion at chamfers and failed encasement at top of pile.

**Severe Condition - 22B** - Top of pile 12" tall encasement 2-3" annulus; NW face 2' below WL, 2' height, heavy spall/erosion with exposed reinforcement, not likely impact related; Light chamfer erosion 1' below MLW on NW face, varying levels of light to moderate erosion down to 12' below MLW, not impact related, marine growth present over defects
