# National Transportation Safety Board

## Marine Accident Brief

### Contact of Liquid Petroleum Gas Carrier *Levant* with Mooring Dolphin

<b>Accident type</b>	Contact	<b>No.</b> DCA20FM006
<b>Vessel name</b>	<i>Levant</i>	
<b>Location</b>	Petrogas Ferndale Wharf, about 5 miles west of Ferndale, Washington <sup>1</sup> 48°50.36' N, 122°43.26' W	
<b>Date</b>	December 15, 2019	
<b>Time</b>	0406 Pacific standard time (coordinated universal time – 8 hours)	
<b>Injuries</b>	None	
<b>Property damage</b>	\$8.25 million est.	<b>BOPC Received</b> <b>02-04-2021</b>
<b>Environmental damage</b>	None	
<b>Weather</b>	Visibility 7 miles, overcast, winds west-northwest at 15 knots, waves 2 feet, air temperature 45°F, water temperature 46°F, sunrise 0751	
<b>Waterway information</b>	Located in the Strait of Georgia, the Petrogas Ferndale Wharf's depth alongside at mean lower low water is about 36 feet, height of tide 2.9 feet, and mean range of tide 5.9 feet.

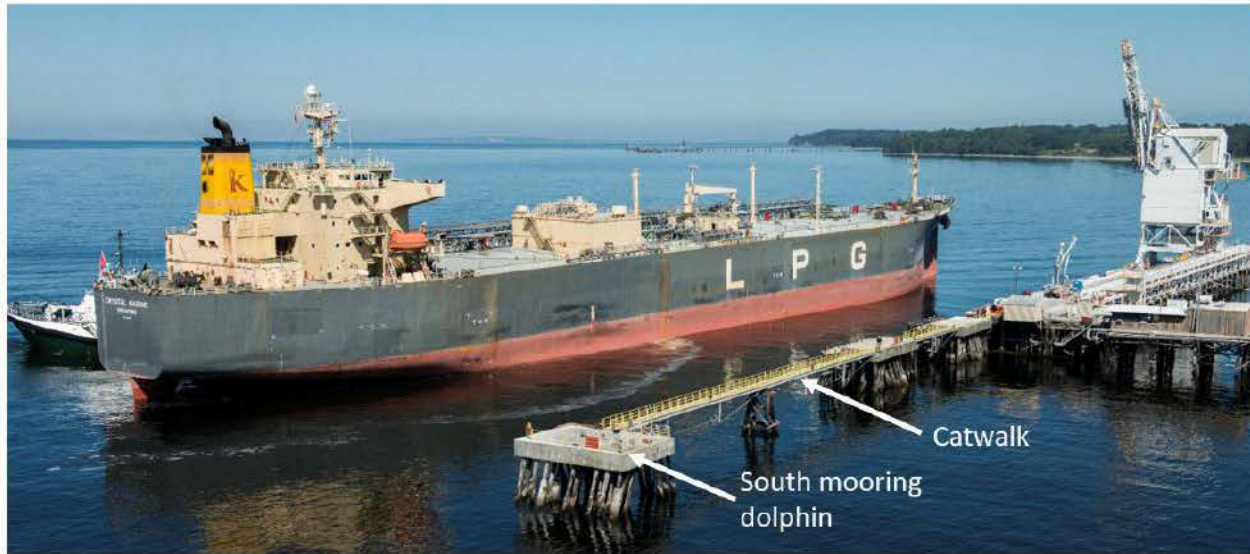
The Petrogas Wharf with a tanker of similar size to the *Levant* docking starboard side to the wharf. (Source: Petrogas, LLC)
