Agenda Item 11A: KONA TRADER IRC Report Attachments

M/V KONA TRADER APPROACH TO PORT OF STOCKTON – MARINE EXCHANGE AIS DATA

KONA TRADER PORT OF STOCKTON BERTH 12/13
DOI Sept 25, 2024

**MISLE Incident Investigation Report
For
KONA TRADER Allision**

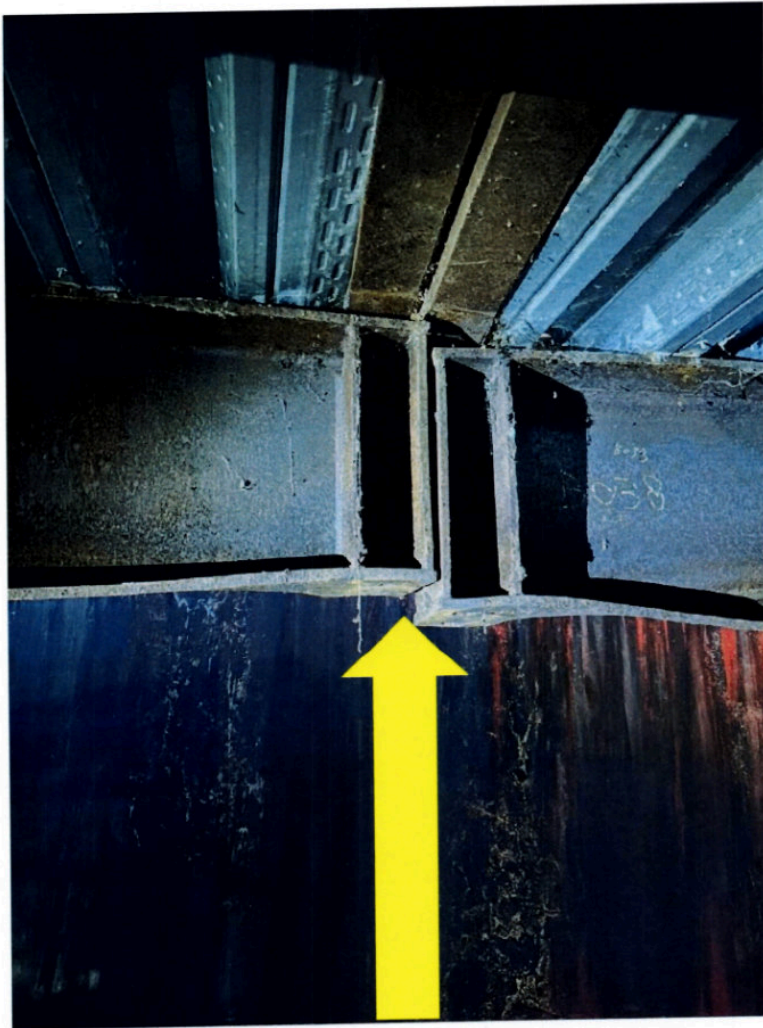
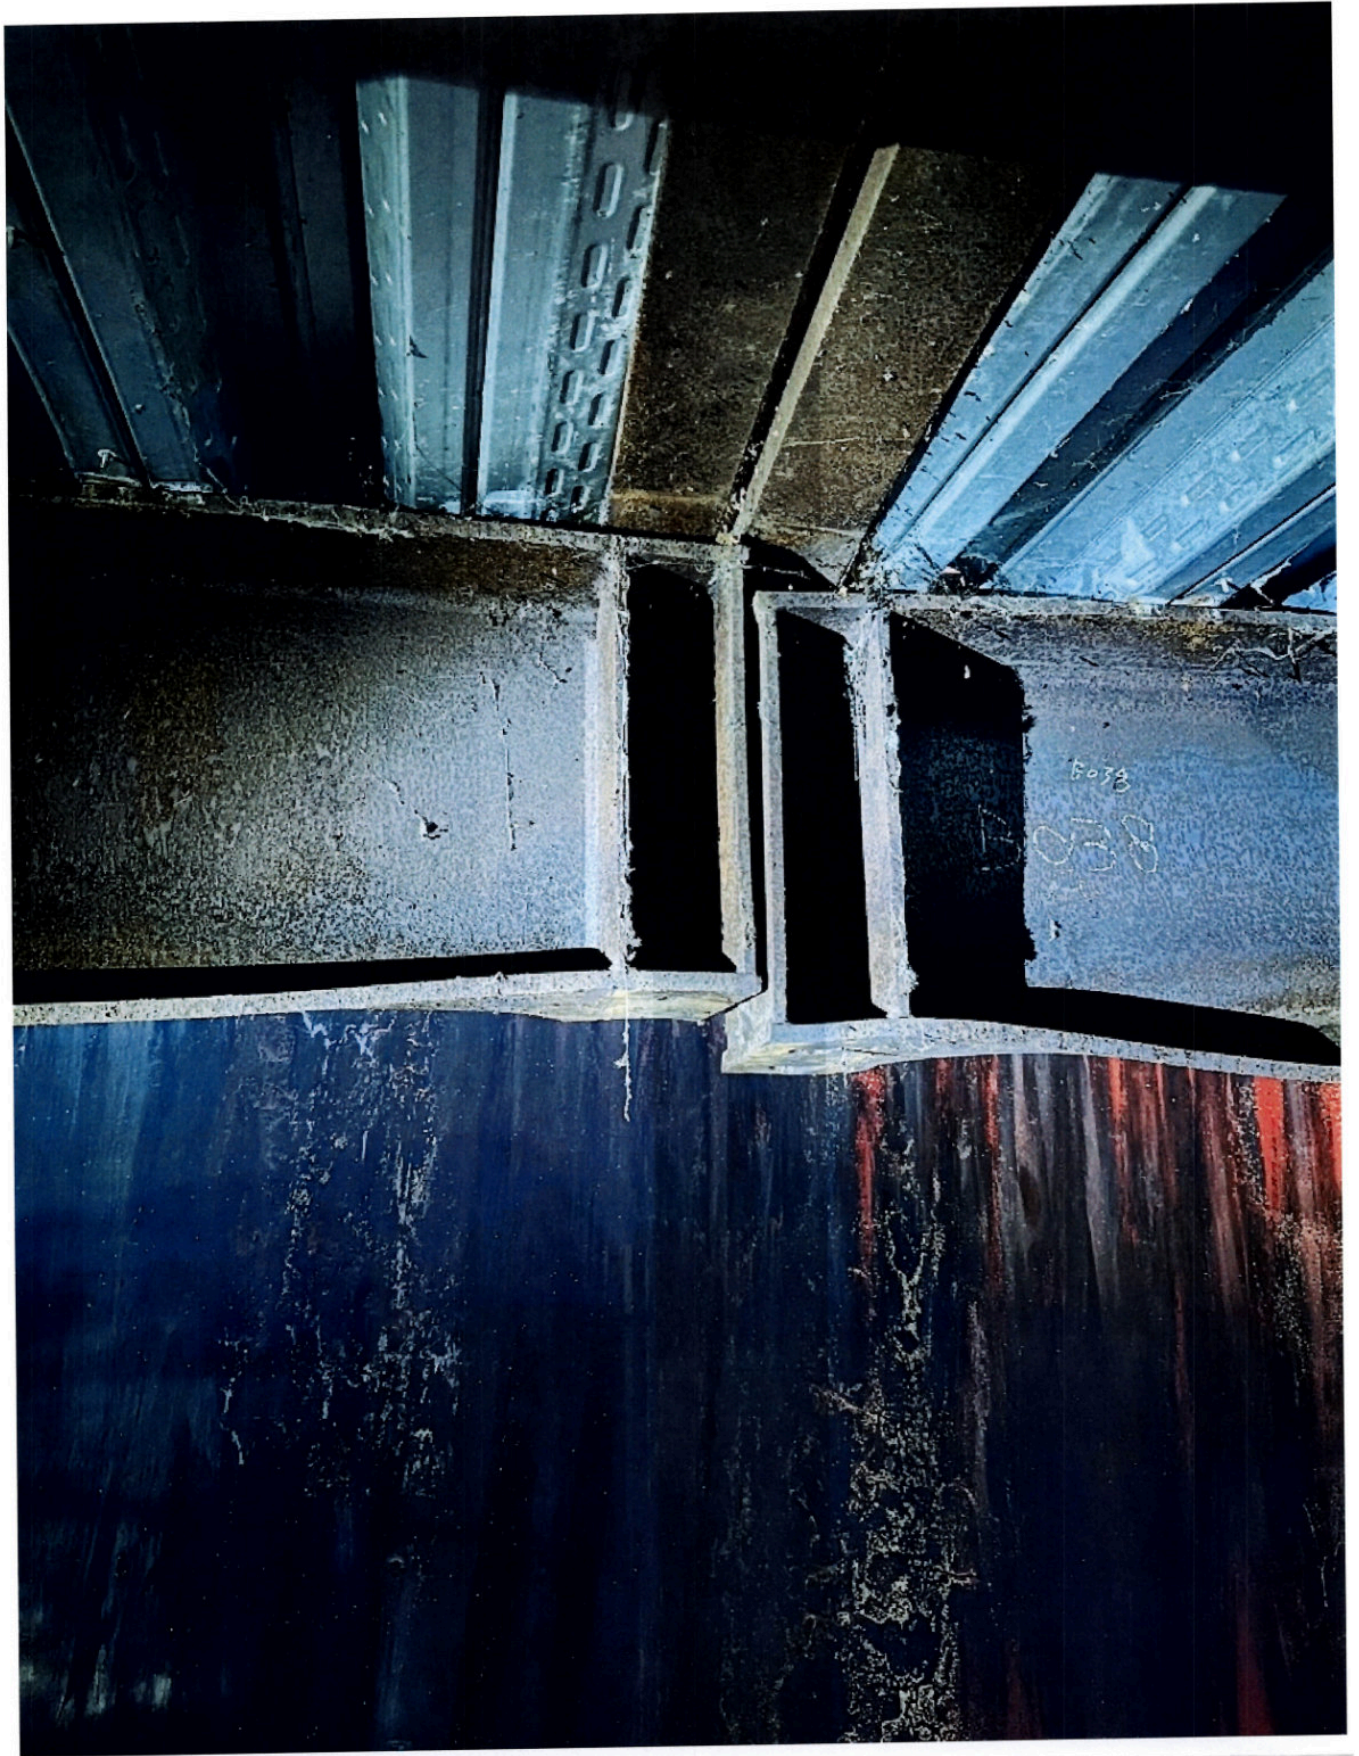
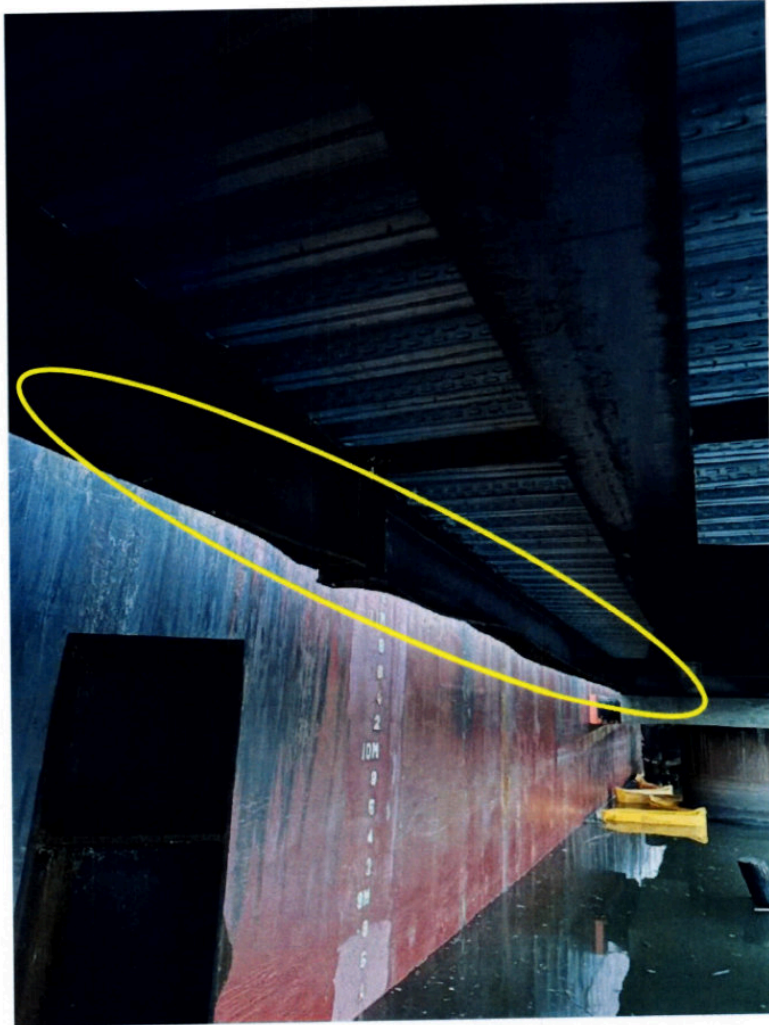
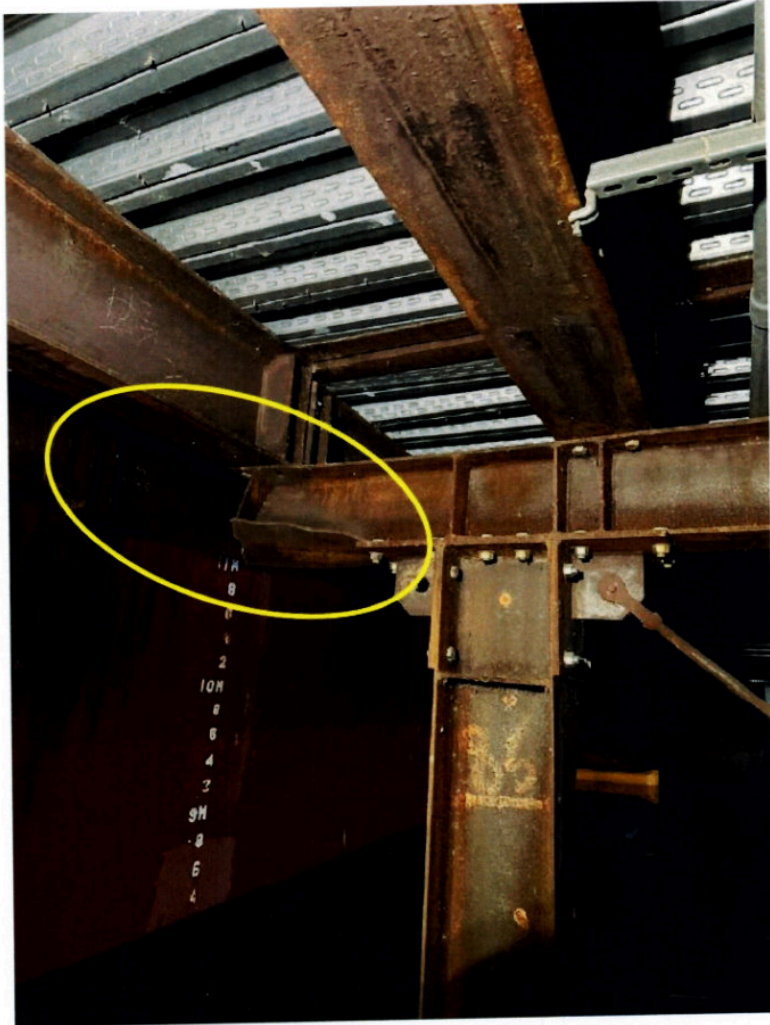
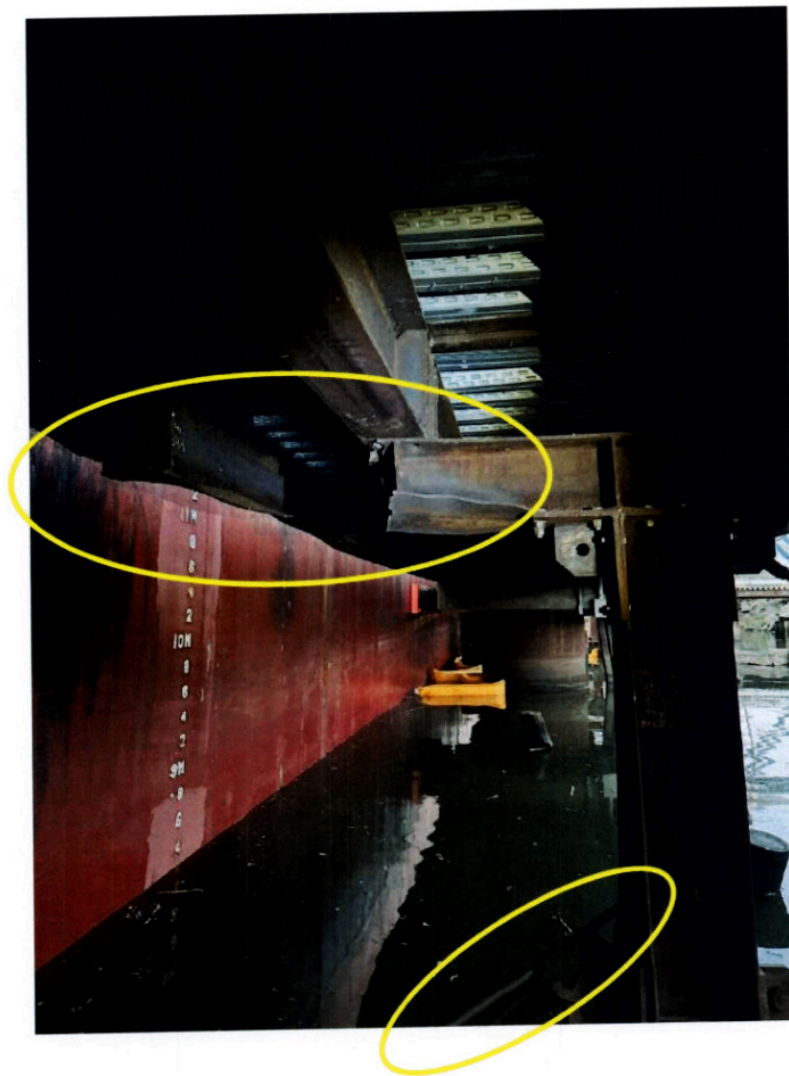
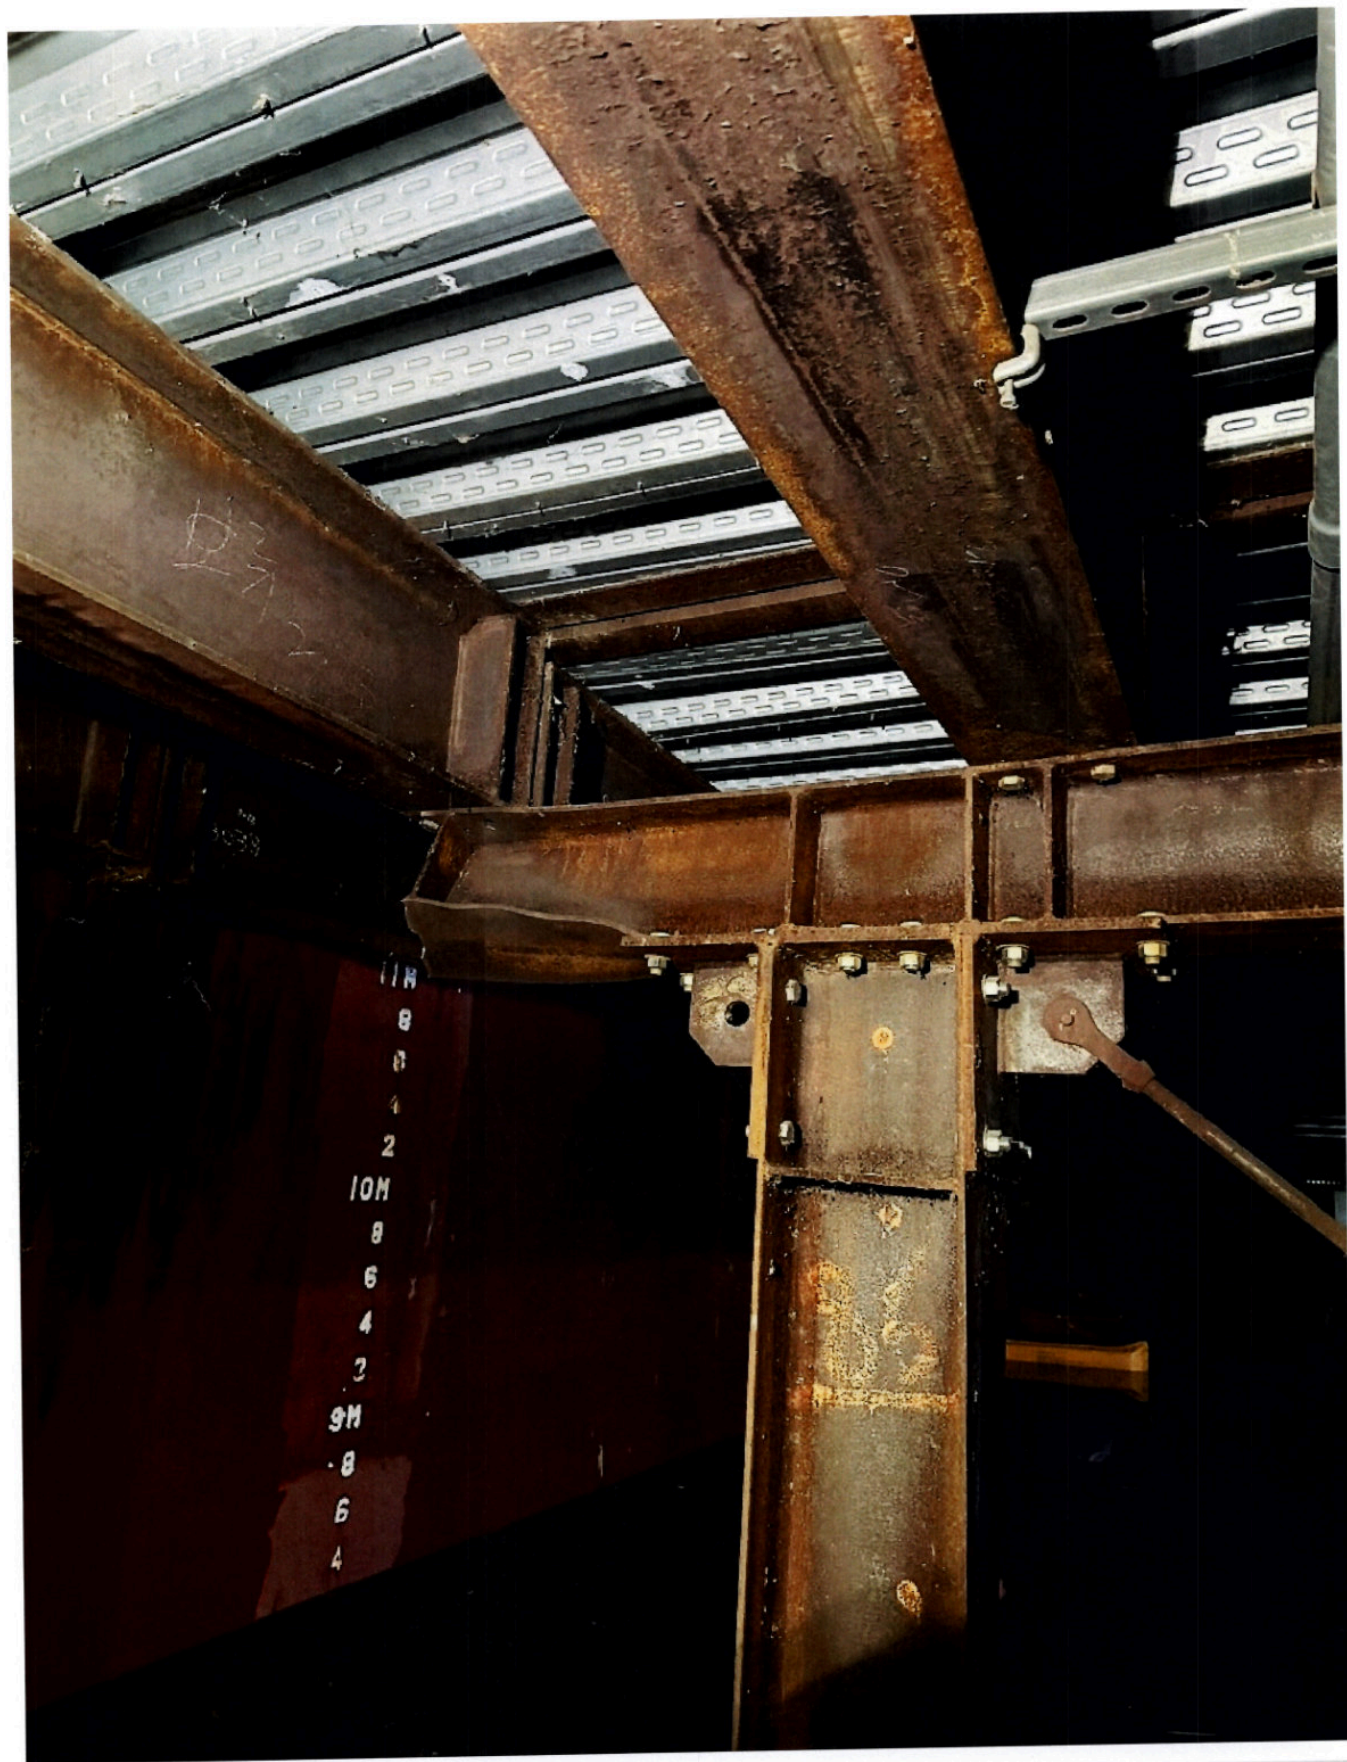
KONA TRADER – Photos of Damage (Sent by (b) (6) , Port of Stockton)

Bolt holes in horizontal structure. Construction details of pier indicate these holes held bolts that appeared to have been sheered off due to ship contact. Vertical structure, shown upper right, was push out 45deg from original position.

Indications of recently fractured concrete on the top surface and water side pier edge were found. Location of the concrete damage is directly above what appears to be the area of contact with the steel support structure under the pier.

Damaged area shown in this photo is same area as show in photo 2, attachment 4, but from a different angle. Note the broken tension rods. This steel pier support detail is repeated several times under the length of the pier. The location shown above is the only one of these details found damaged.

The concrete pier deck is supported by several "I" beams. The one above is supports the ship side of the pier. It shows damage to the flange and web over 10' of length. The location is consistent with the area of contact.

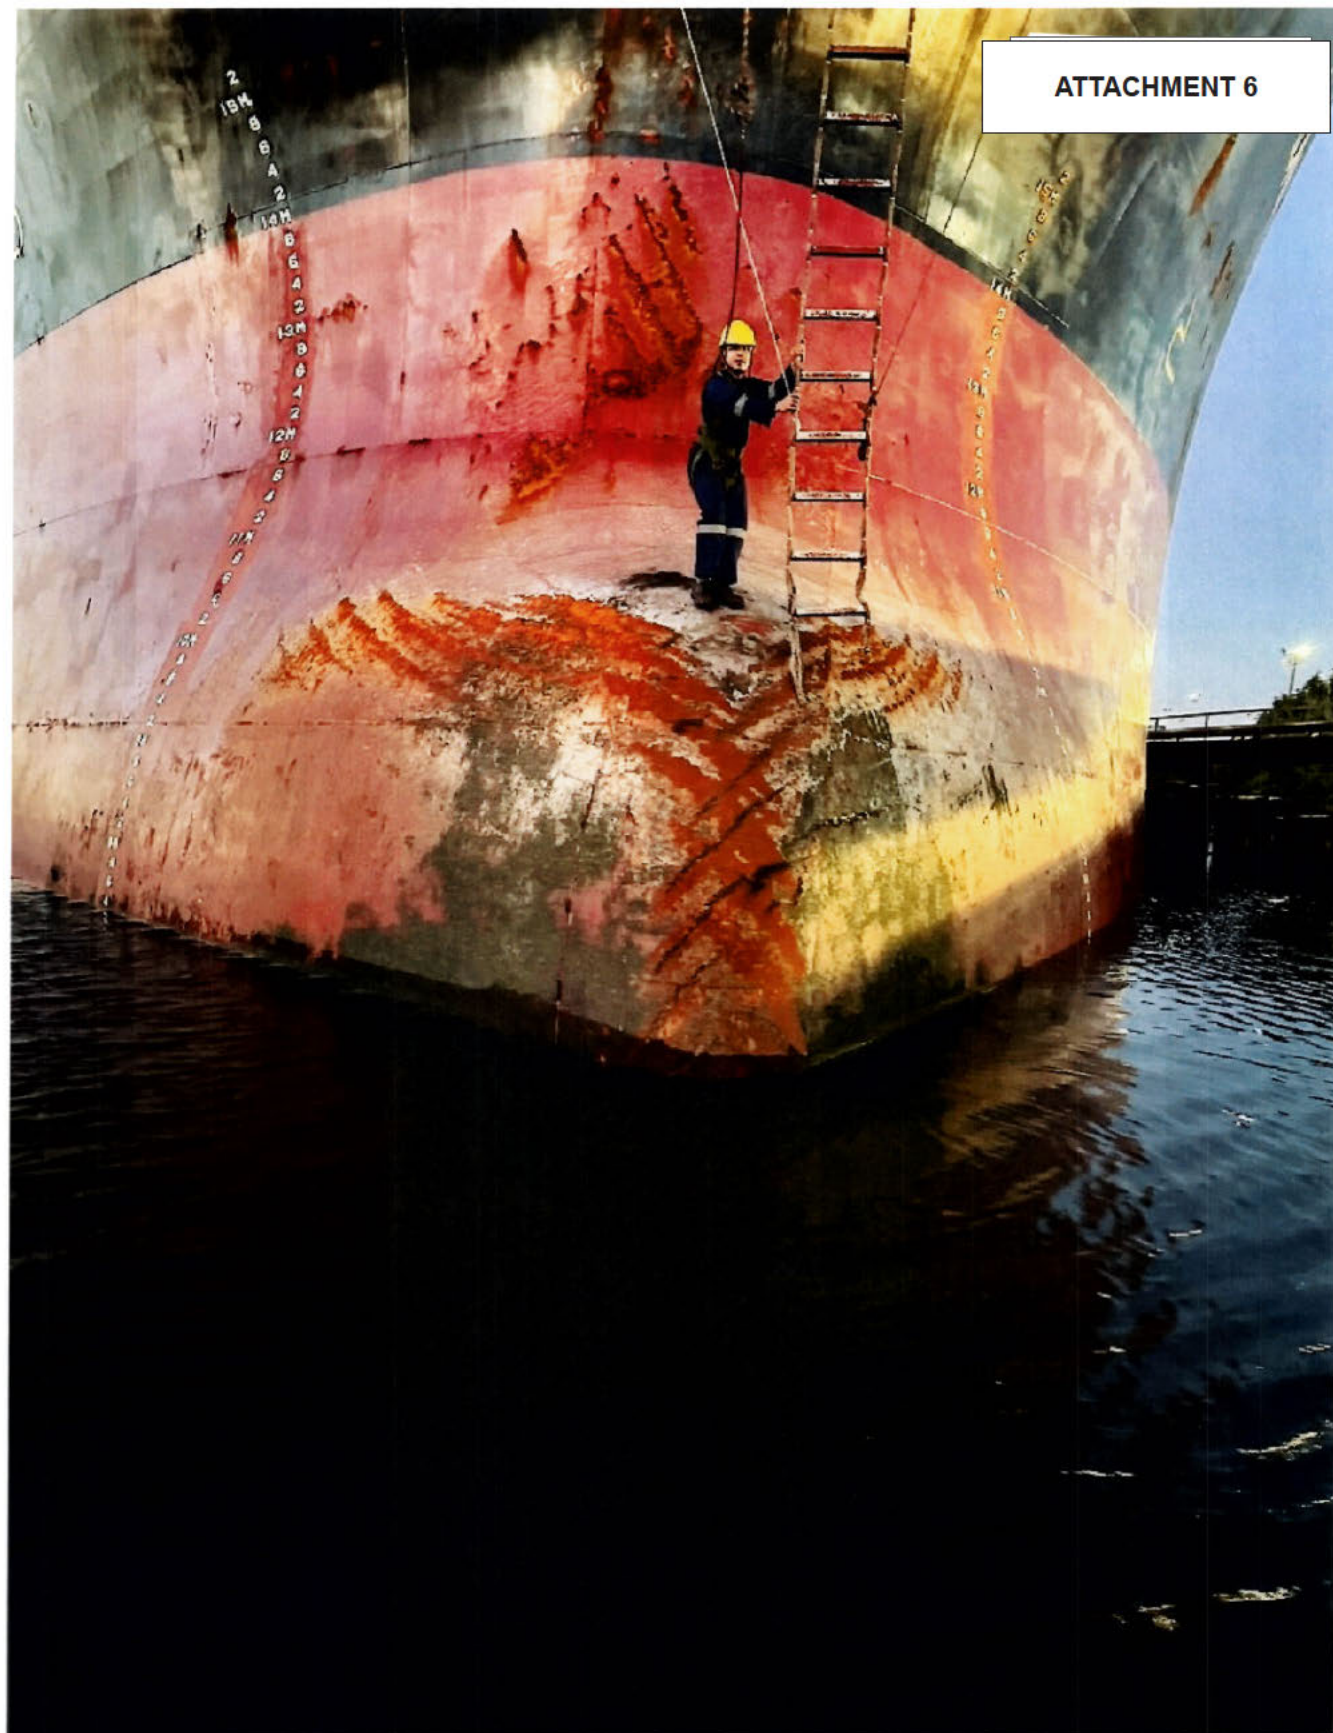
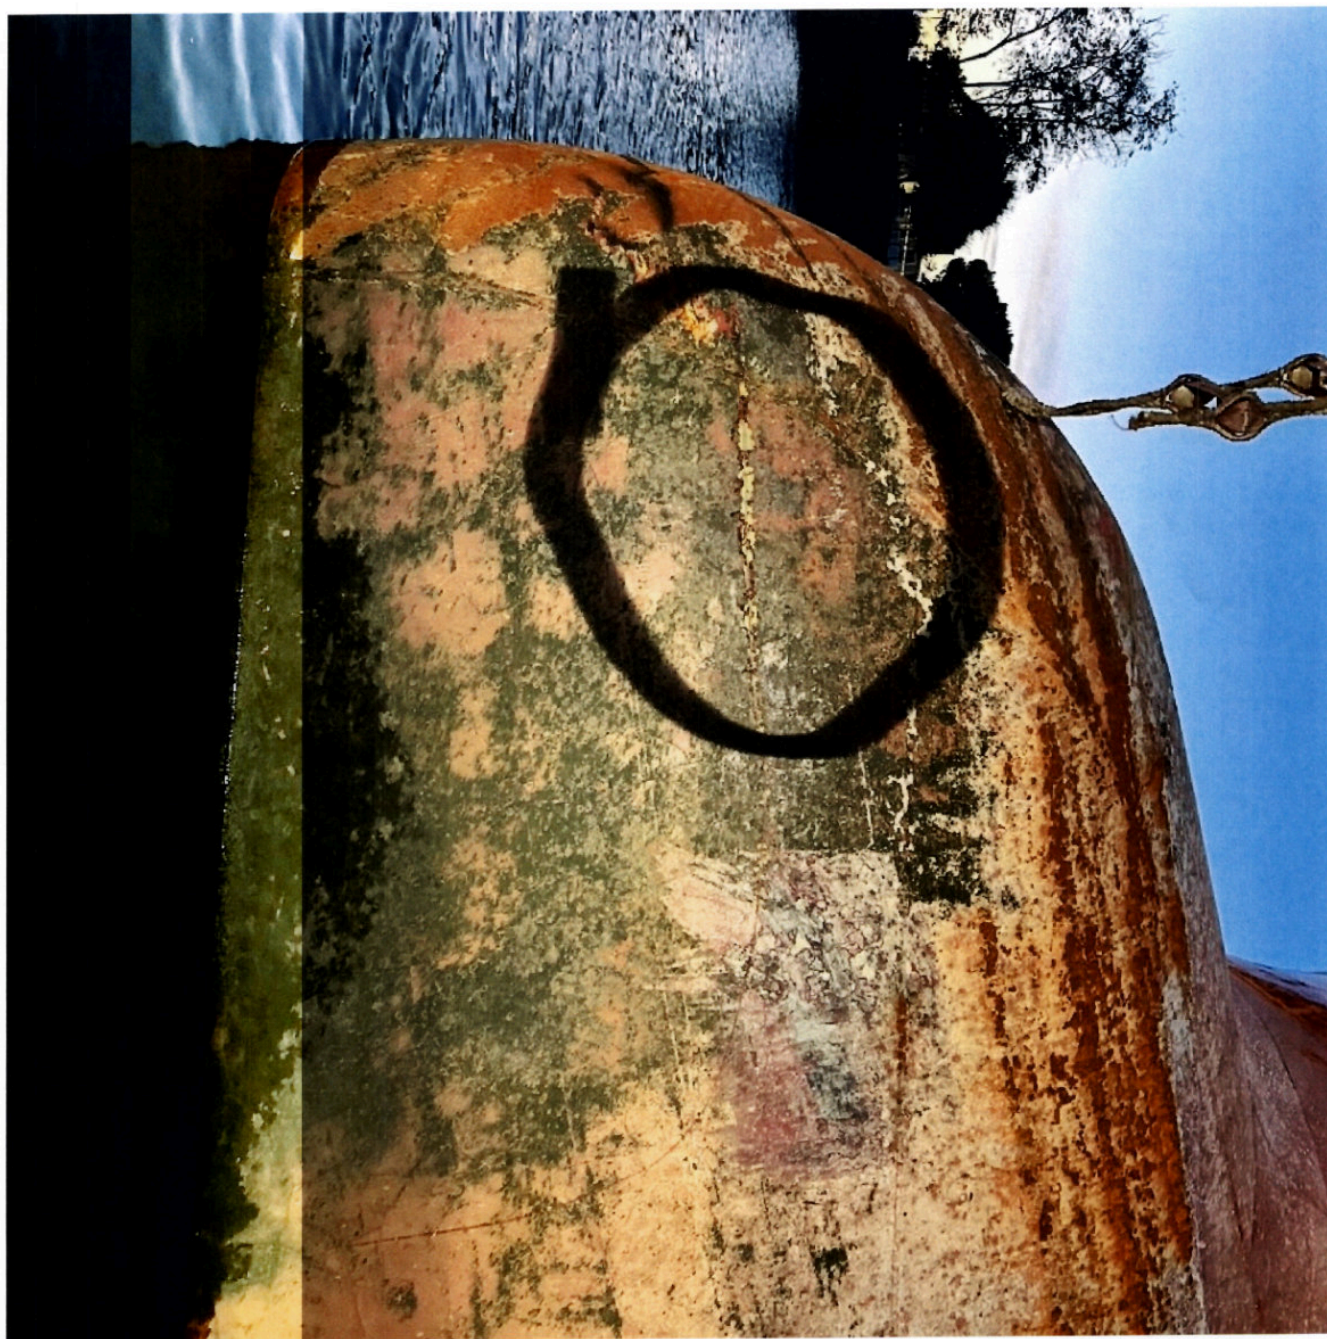
Attachment 6: M/V KONA TRADER, Photographs of Vessel Damage

Damage to coatings on bulbous bow were consistent with the age of the hull coatings. No conclusions could be draw by commission investigator of the impact location on the ship through inspecting the bow.

The survey found no apparent signs of buckling, penetrations, indentations, or any other structure damage. There is no loss of critical components of the vessel.
