CONDITION AND VALUATION SURVEY / APPRAISAL REPORT

VESSEL: "Golden Gate"

File No. 20052

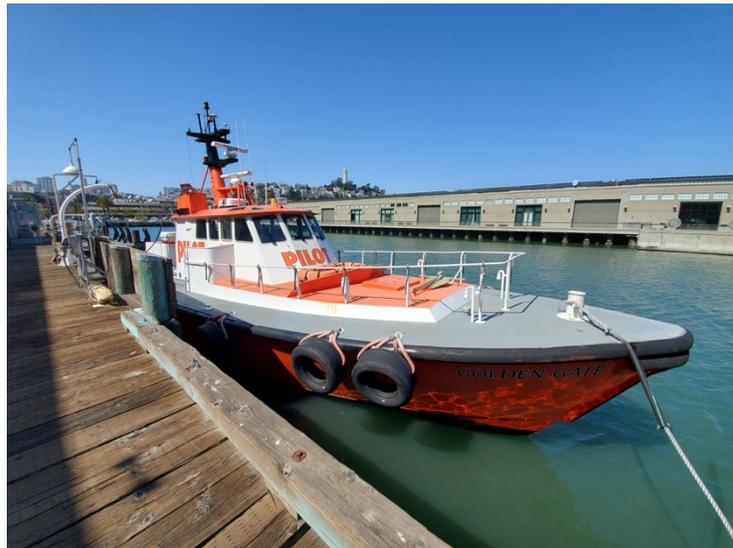
This is a custom built, all welded aluminum hull pilot vessel with a raked bow and a plumb stern. The hull has a moderately deep keel, moderate deadrise, and hard chines. The hull is well fendered with "D" rubber all around at the sheer. The underwater body has four (12) grid coolers and two (8) grid coolers set in recessed pockets for engine and genset cooling. There is a welded seachest forward in the engine room with a screen outside and a zinc anode welded in the inside. There is a large foredeck and ample side decks with railings all around, inset to allow transfer of personnel. The cabin is amidships, with the helm forward and passenger seating aft. The aft deck has a raised engine room trunk, and an aft steering station to starboard.

There are steps down the stern amidships, with a man overboard recovery ramp adjacent.

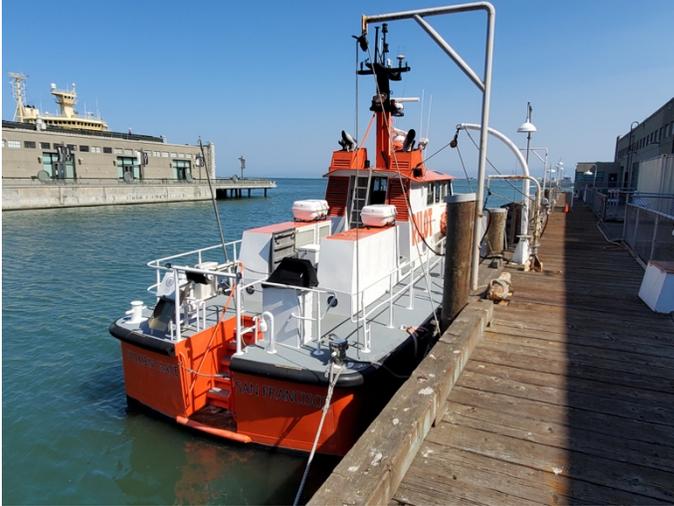
Aft of this is the lounge, galley, and berthing area with a full head to starboard. The engine compartment contains the two main engines and two auxiliary generator sets. There is an aft escape hatch in the engine room. The steering gear is contained in the lazarette aft.

Fuel tankage is below the amidships bilge space, and in the engine room.
