**CONDITION AND VALUATION SURVEY / APPRAISAL REPORT**

VESSEL: "PITTSBURG"

File No. 20040

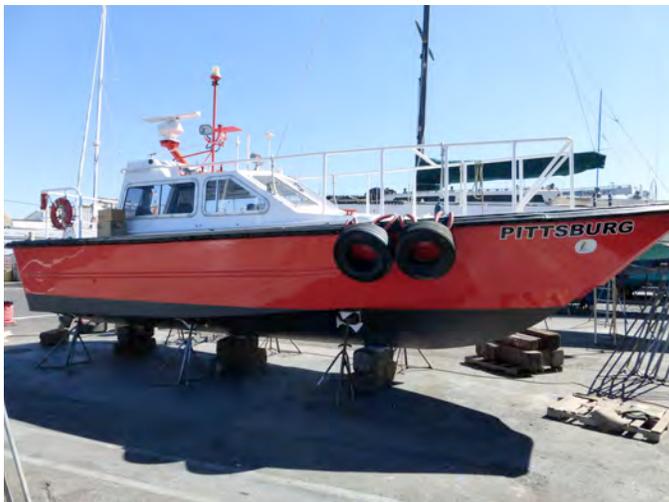
There is an open foredeck with diamond plate with non-skid coating applied, followed by a low deckhouse and an open aft deck. There are heavy pipe handrails surrounding the foredeck and leading aft forming grab rails along the house. The aft deck is surrounded by rails.

The bow is scow shaped and the slab sides forward form a hard chine creating a spray rail. The underbody hull has a fine entry forming a shallow keel with moderate deadrise. The transom is nearly flat and has bars across to protect the stern drives.
