**INCIDENT REVIEW COMMITTEE  
INVESTIGATION REPORT**

**REPORT ON THE ALLISION OF THE BULK CARRIER M/V NEW HANDY  
WITH SAN JOAQUIN RIVER NAVIGATION MARKER #39 ON JULY 23, 2023.  
PILOT: CAPTAIN RAYMOND RIDENS**

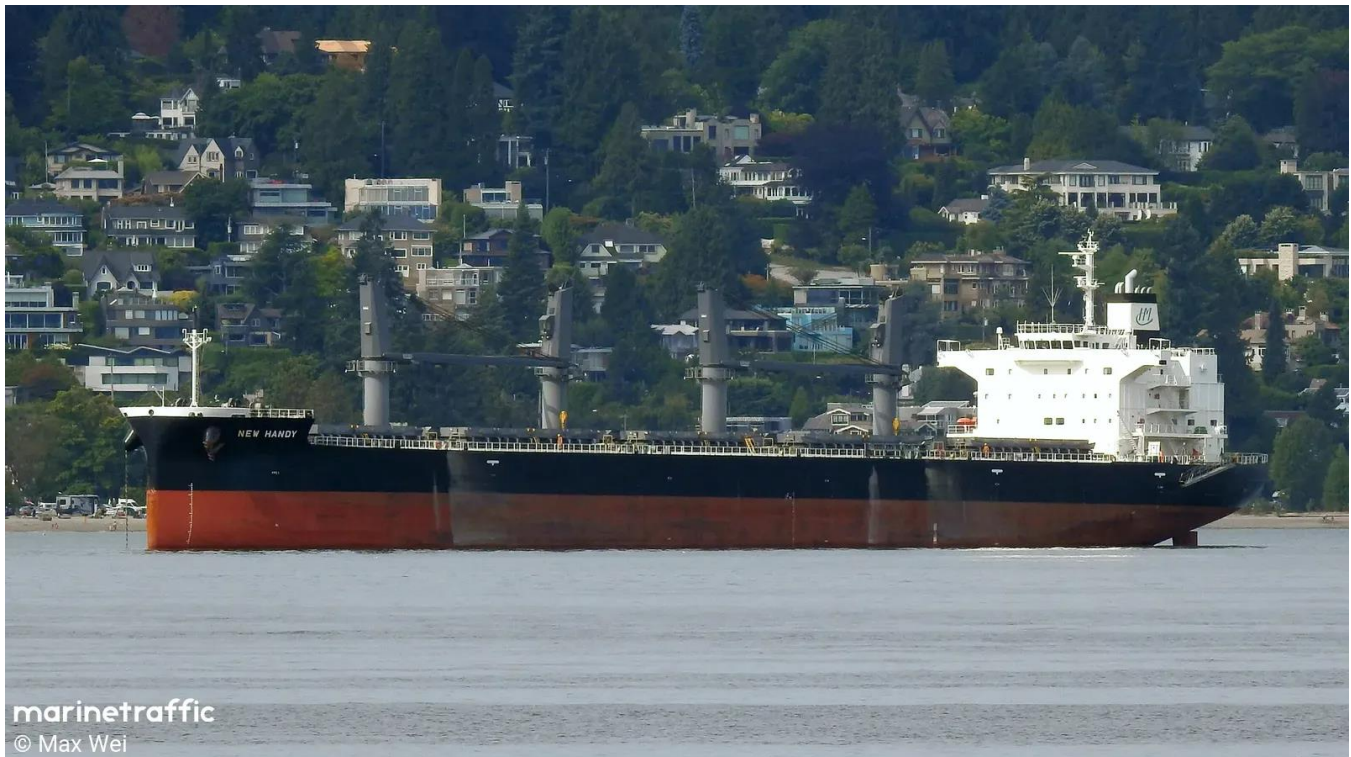
Vessel Particulars:

- Length: 600 feet    Beam: 105 feet
- Actual Draft: 28 feet 01 inches aft (deep draft)
- Tonnage: 25,756 gross tons
- Propulsion: Diesel Engine
- Owner: Hsin Chien Marine, Taipei, Taiwan
