From: Sezai Gorgu [REDACTED]
Sent: Friday, December 13, 2024 11:36 AM
To: Garfinkle, Allen@BOPC [REDACTED]
Cc: Operations [REDACTED]; FLEET-HK-TKROPS [REDACTED]
[REDACTED]; fleet-hk-techT5 [REDACTED]; Alvaro Rodriguez
[REDACTED]
Subject: FW: URGENT - RE: EASTERLY LIME GALAXY V-202410 Pilot Arrangement Deficiency Report (_GAUS0393333_)

Please see attached "Pilot Boarding Arrangements Deficiency Report" filed by one of our licensees.

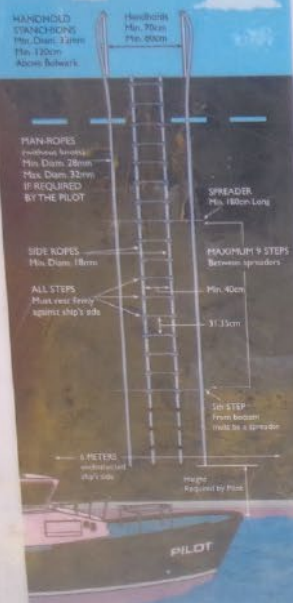
RIGGING FOR FREEBOARDS OF 9 METERS OR LESS

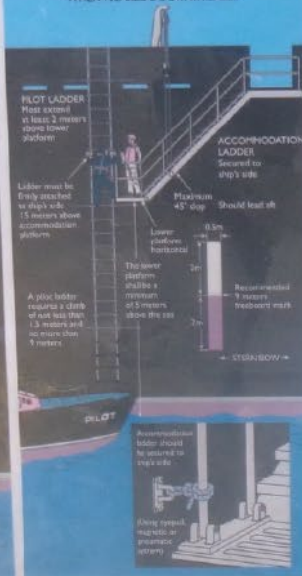
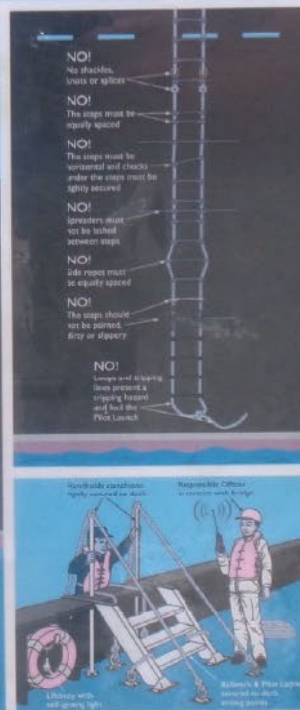
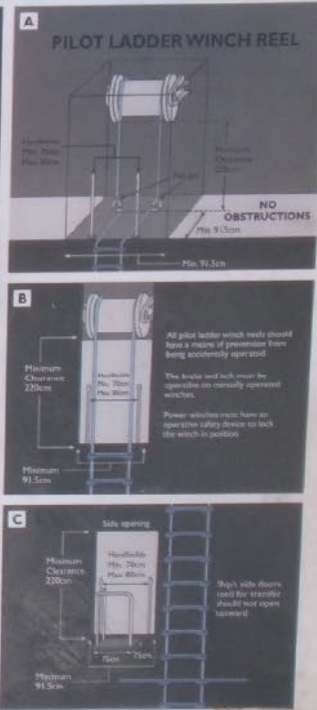
COMBINATION ARRANGEMENT FOR SHIPS WITH A FREEBOARD OF MORE THAN 9 METERS WHEN NO SIDE DOOR AVAILABLE
